Inspection Report

Report #: 6972

110 INTRODUCTION

At your request, we have performed a limited visual survey of specific construction components of the property located at 2902 59th Street West Bradenton FL. The date of the survey was 11/12/2015. Please see Section 200 of this report for a description of specific components which were assessed, and also Section 1200 for exclusions of this assessment.

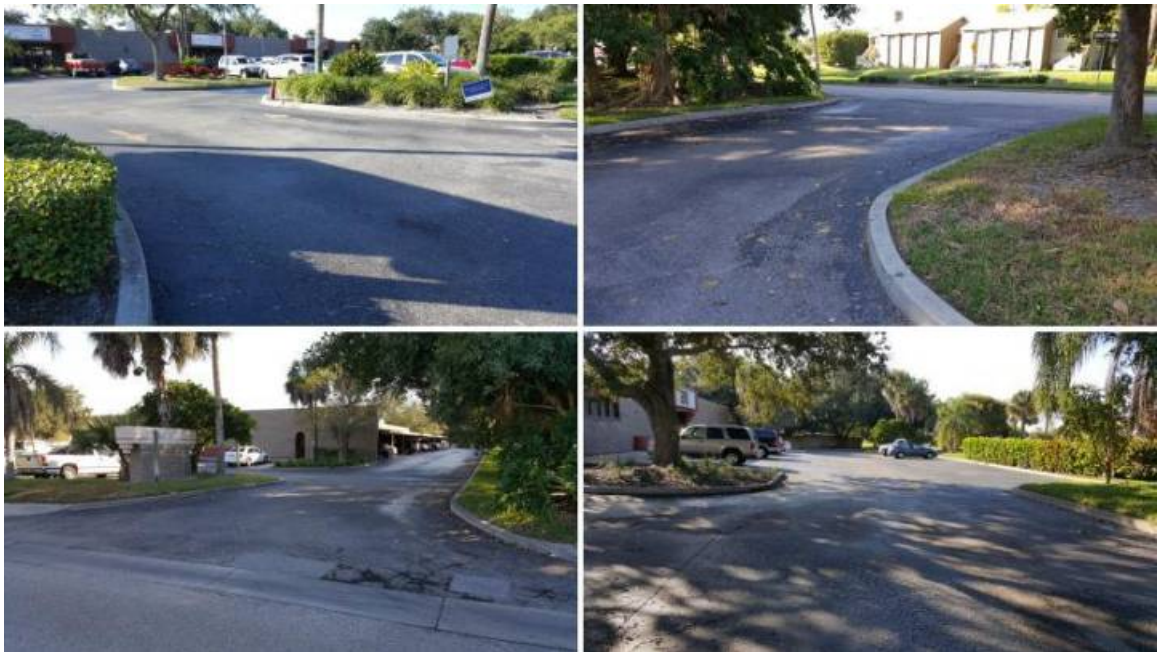
414.0 Paving, Curbing and Parking

All parking surfaces on the lot are paved with asphalt. Paving appears adequate, however, noticeable surface deterioration (cracks and spider-webbing) of the asphalt surface is noted. Re-surfacing of the asphalt will be needed within the next 5-10 years. Repair / sealing the deteriorated areas of asphalt are needed to prevent damage. **Estimated Cost to Correct \$5,000 - \$8,000**

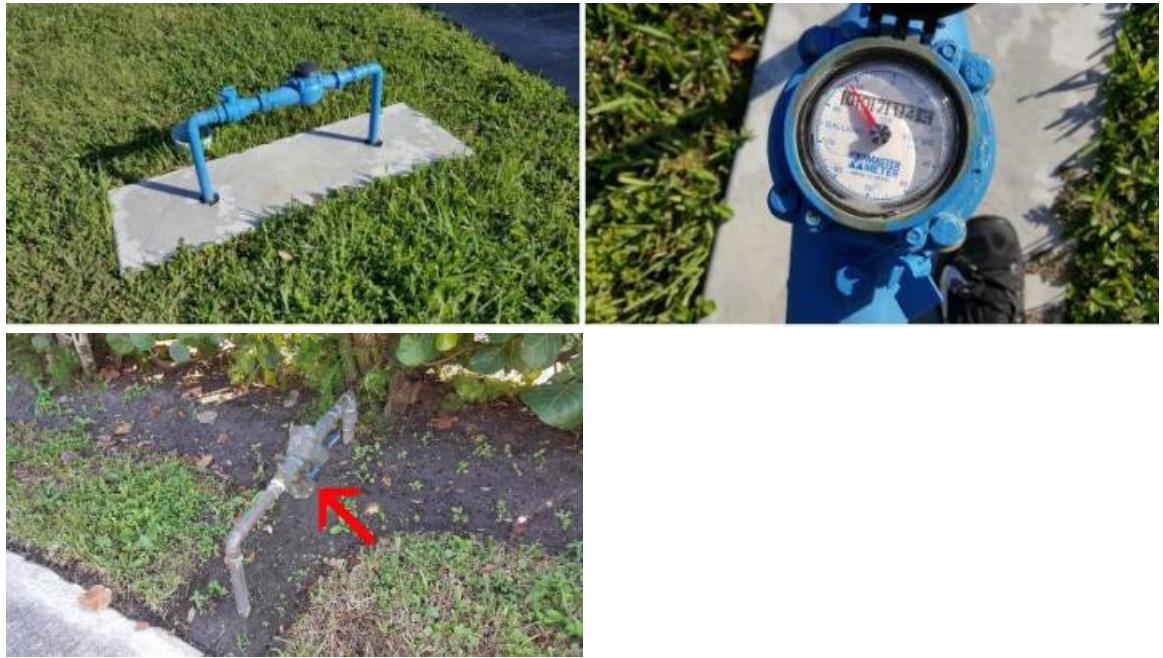
Main water service is located at the right side of property near the street. The back flow prevention valve has periodic leaking noted and no valid inspection sticker present. **Estimated Cost to Correct = \$350 - \$650.**

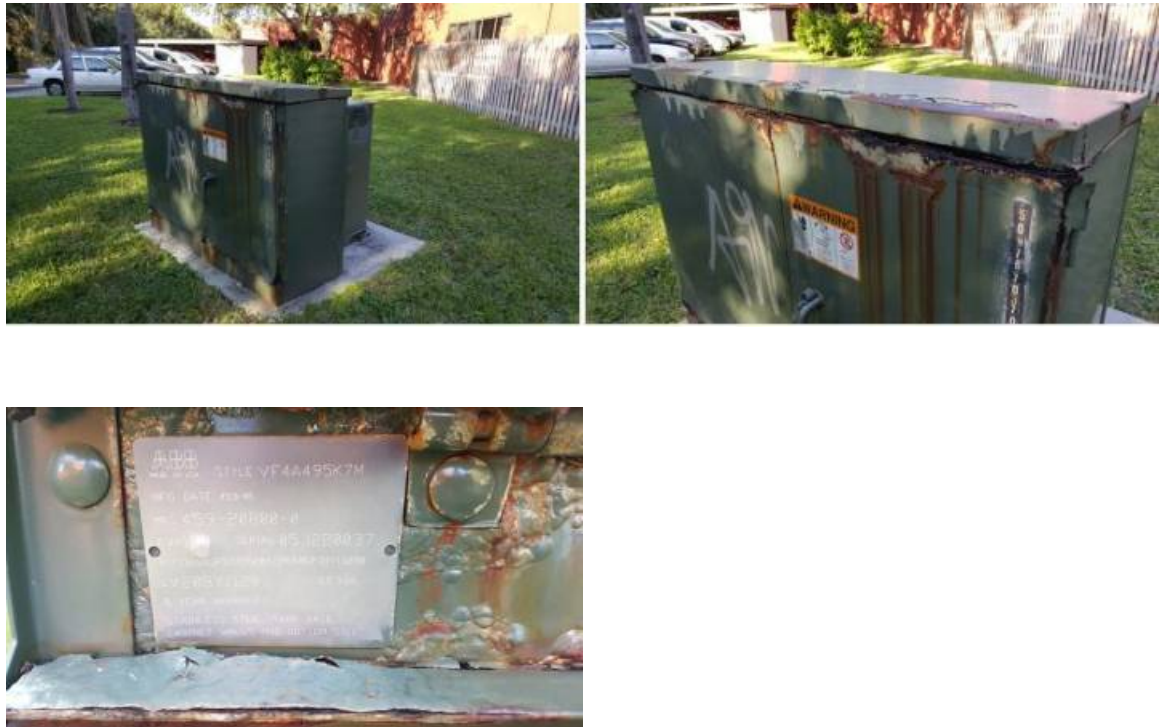
422.0 Electricity

The main electrical service is underground and located at the rear of the property. The main service box (a 150KVA Pad Mount Transformer) has significant visible deterioration and will need further evaluation by a licensed and insured commercial electrical contractor to determine the condition, operation and remaining useful of the main service transformer. **Estimated Cost to Correct = UNKNOWN- further evaluation needed.**

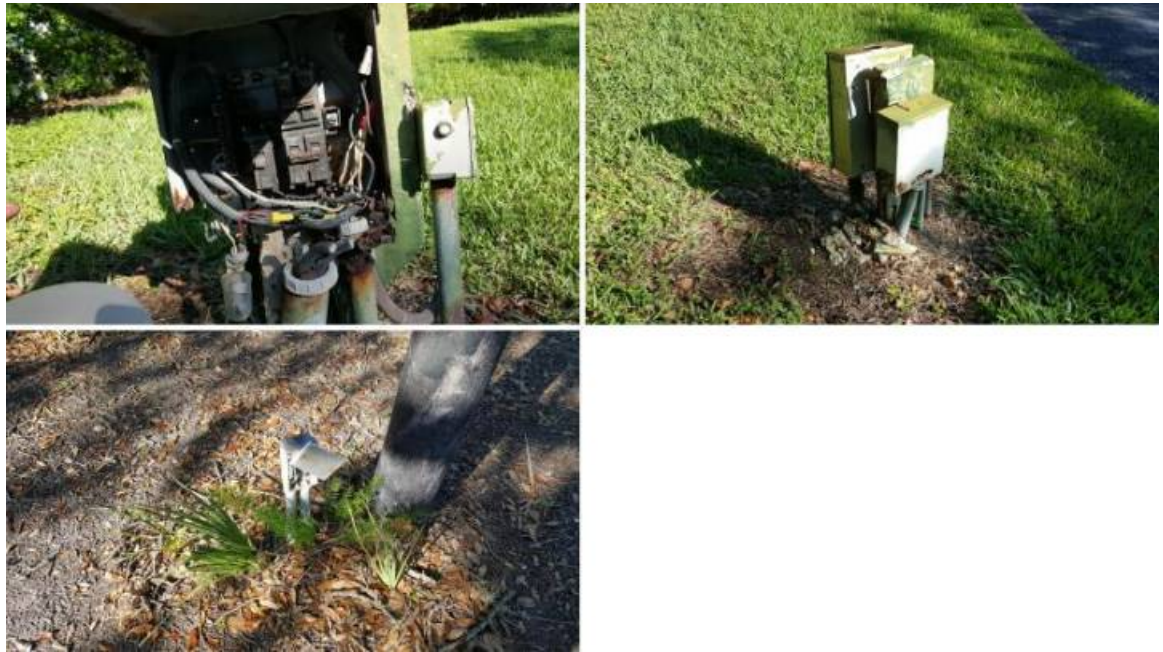
422.1 Electricity

An open, damaged electrical panel and junctions boxes are noted at north, east corner of property. No power is present and these components appear to be abandoned. Have a licensed and insured electrical contractor provide further evaluation and removal on abandoned electrical components / hazards. **Estimated Cost to Correct = \$300 - \$500.**

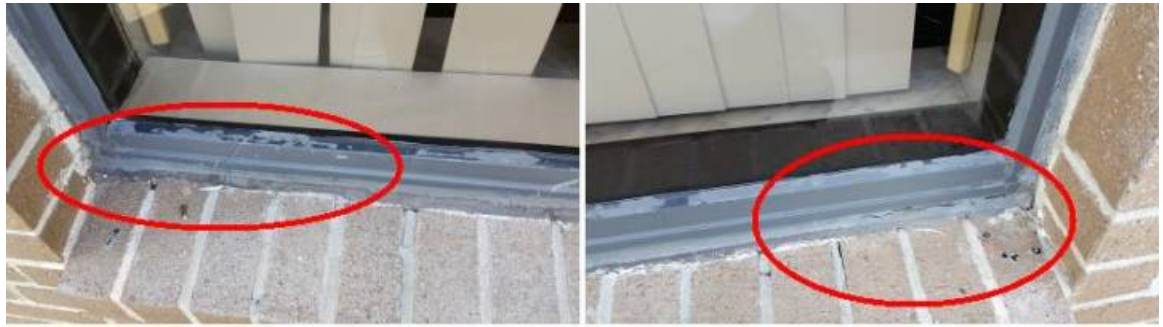
| <p>521 Exterior Wall Systems</p> | <p>The majority of sidewall cladding consists of stucco and brick and stucco. <u>There are minor openings noted around the window and exterior walls of UNITS "R" & "A". Water penetration is noted inside the lounge area of UNIT R. Caulk and seal all exterior side of windows as needed.</u> Estimated Cost to Correct = \$500 - \$800.</p> |

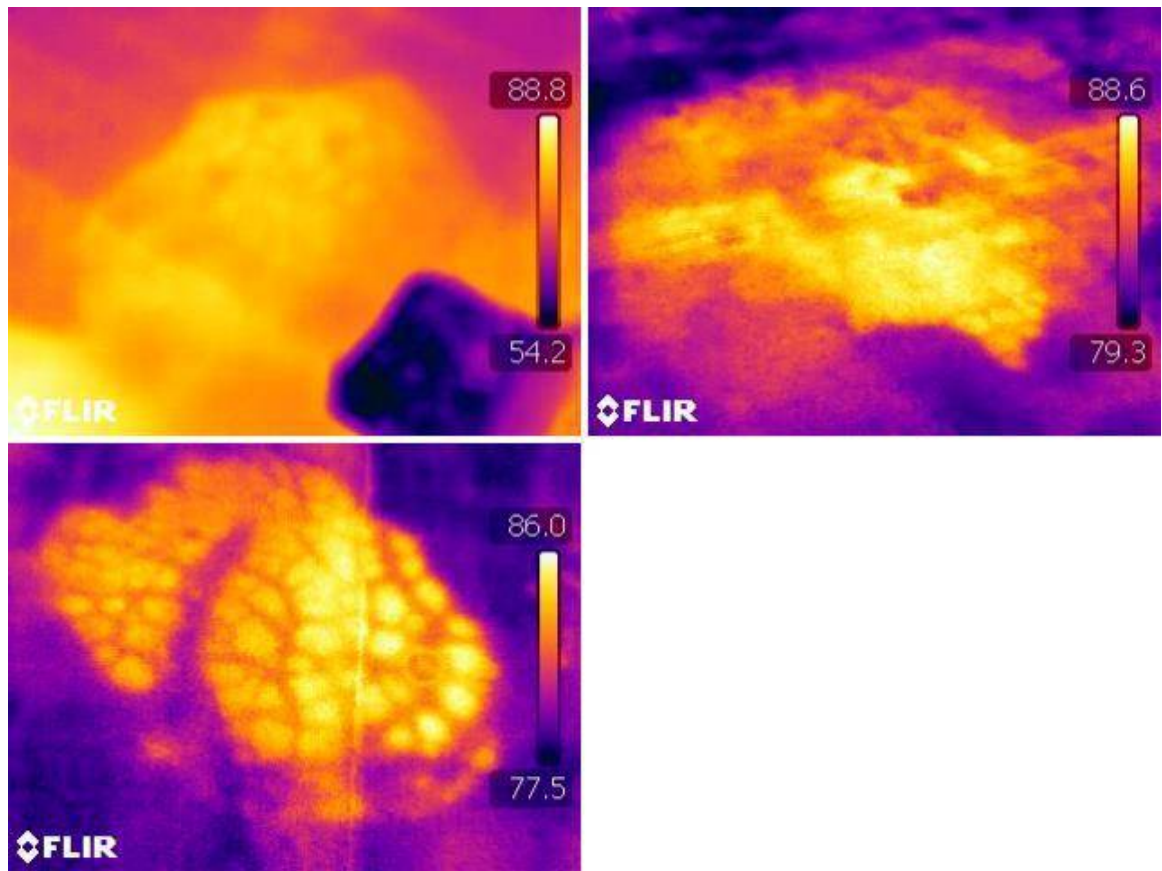
- 533 Roof Covering Condition: The roof covering has recently received a multitude patches and repairs indicating past leaks. The repairs appear to be consistent with quality repairs installed by an experienced commercial roofing contractor. There is thermographic evidence of areas where water has penetrated the roof covering and has been confirmed by moisture meter readings. Trapped moisture is common result of patching a roof having previous leaks. Water has previously penetrated the roof covering and due to patching the moisture is currently sealed under the roof covering. These areas will eventually need to be replaced however, since the roof covering has a remaining useful life of approximately 5 years it is recommended to replace these areas when a comprehensive roof replacement is conducted. For additional images and thermography of roof covering refer to the PHOTO SECTION 1800.

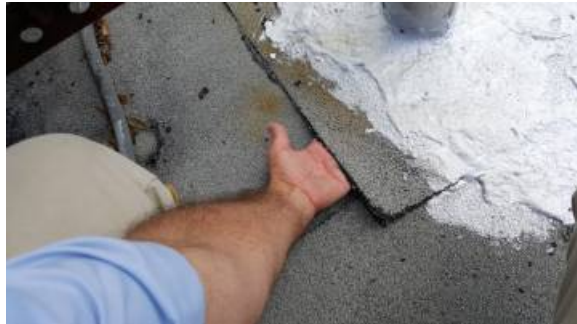
534 Roof Vents & Flashings:

Majority of the flashings have been repaired / patched over and appear in good condition. Several flashings are in need of re-sealing near the southernmost bank of a/c compressors at the compressor mounts to the roof surface. **Estimated Cost to Correct = \$500 - \$700.**

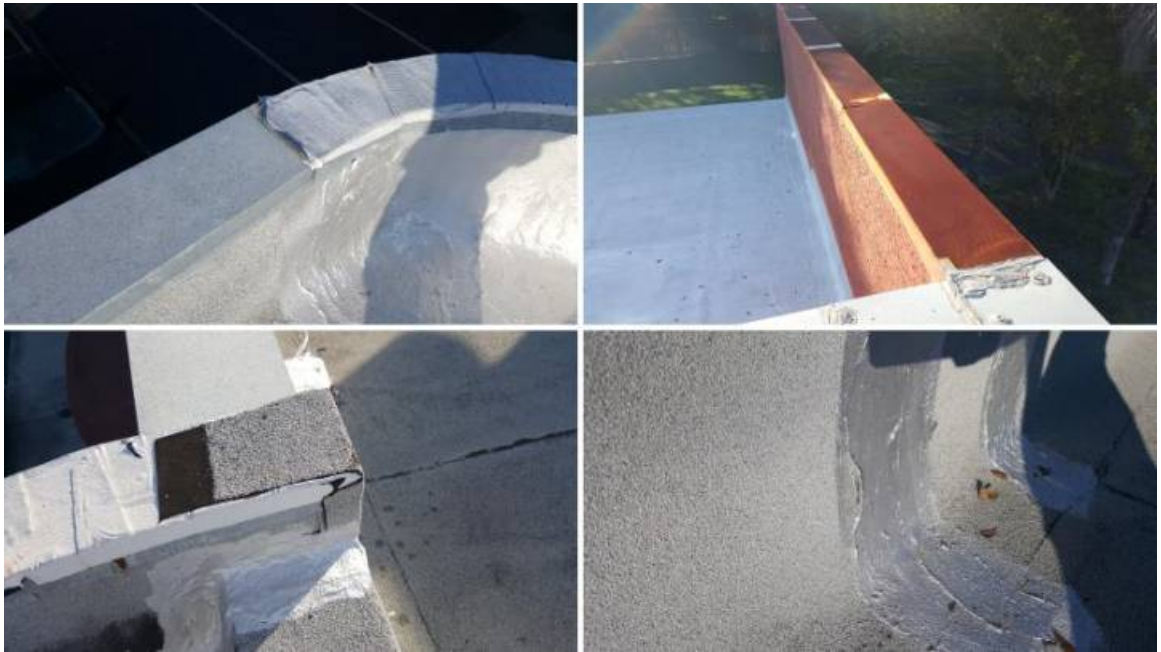
535 Parapet Condition:

Parapet walls generally appear in good condition however, there are several minor areas where the parapet wall cap flashing has open seams / joists. **Estimated Cost to Correct = \$300 - \$400.**

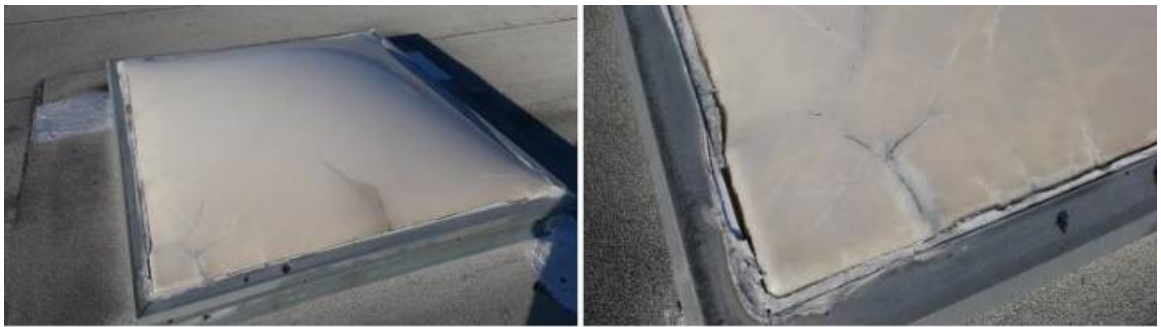
537 Skylights:

Two skylights are present had have damaged present which will allow water to penetrate. **Estimated Cost to Correct = \$800 - \$1200.**

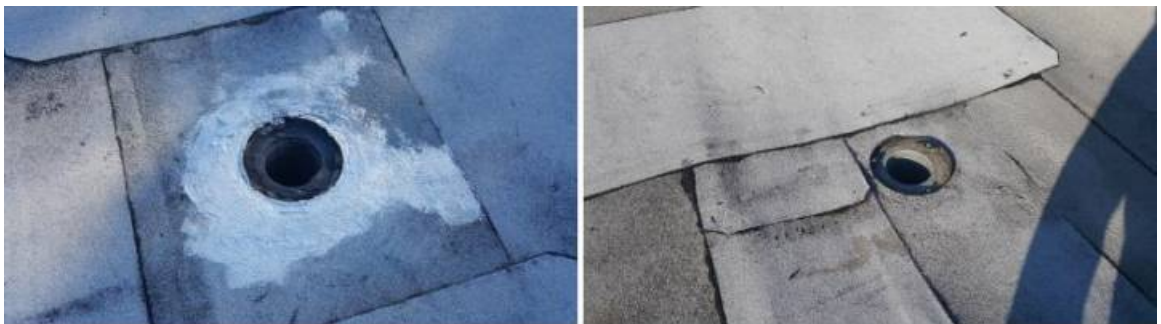
538 Roof Drainage:

Roof drainage is achieved through the use of surface drains and scuppers at the rear parapet walls. Majority of drainage system components appear in good condition however, there are several surface drain strainer caps missing. In addition several past and one current water leak has been identified at the same locations as the surface drains. Have a licensed and insured commercial roofing contractor properly re-seal the surface drains and Install all missing surface drain caps. **Estimated Cost to Correct = \$650-\$900.**

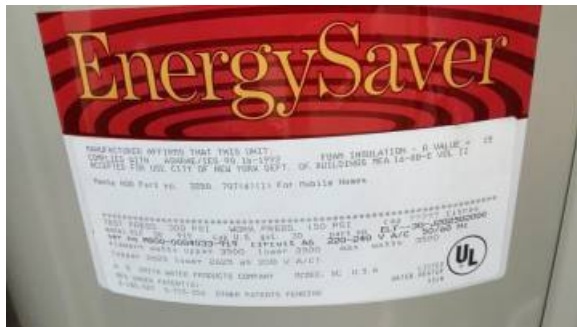
Located in Unit V. Type: Electric. Estimated age is approximately 15 years. Condition: Fair conditions. Unit is operational however, nearing the end of it's useful life. **Cost to Replace \$450- \$550.**

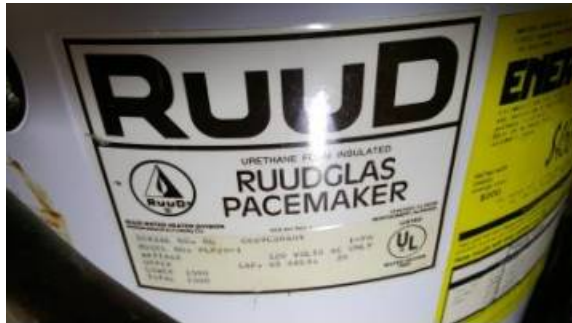
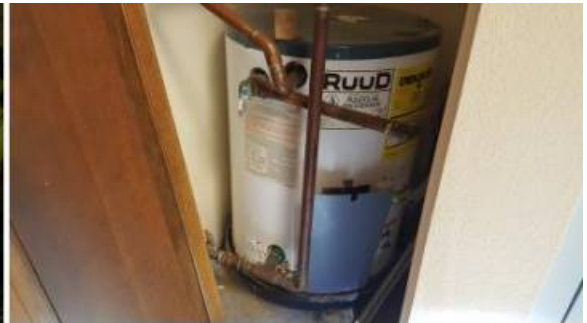
620.5 Water Heater #5:

Located in Unit S. Type: Electric. 20 gallon capacity. Estimated age is approximately 26 years. Currently beyond its designed useful life. Expect replacement within the 1-5 years. Condition: Evidence of current leaking is noted the tank. **Cost to Replace \$450- \$550.**

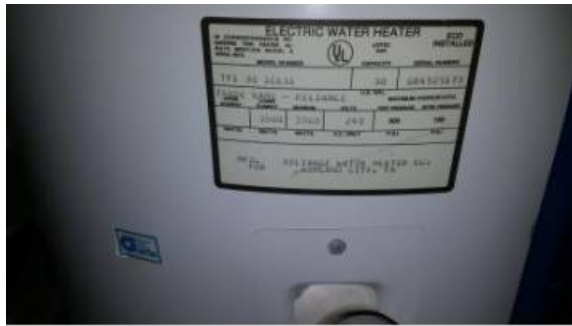
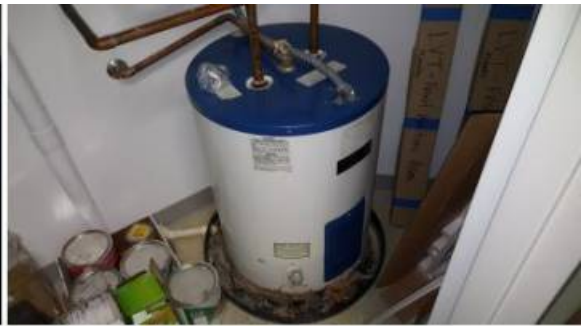
620.12 Water Heater #12:

Located in Unit A. Type: Electric. 30 gallon capacity. Estimated age is approximately 31 years. Currently beyond its designed useful life. Expect replacement within the 1-5 years. Condition: Evidence of current leaking is noted the tank. **Cost to Replace \$450- \$550.**

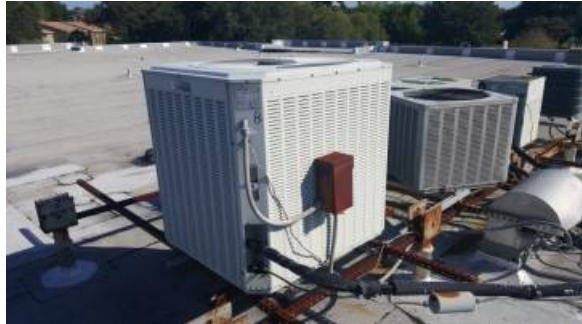
701.3 System Condition:

Visibly appears in operational condition. Evaporator coils have material build-up present. Temperature drop is approximately 12 degrees.

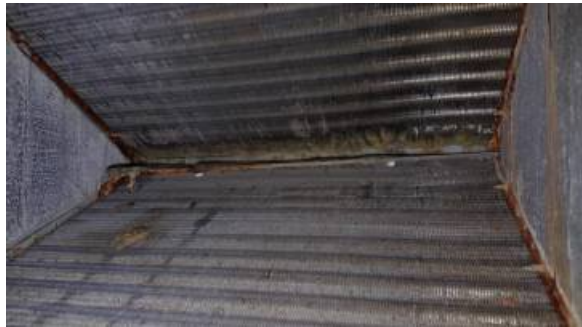
701.4 System Components:

Refrigerant lines, Insulation wrap at suction lines appear in good condition. Ductwork: Visible sections of ductwork appear in good condition. Filters, Filter(s) noted appear clean and appropriately sized. Evaporator Coils, The aluminum fins on the upwind side of the evaporator coils inside air handler are covered with dust and dirt. The coils should be cleaned by a licensed and insured air conditioning contractor to restore adequate air flow through system. **Estimated Cost to Correct = \$350 - \$500.**

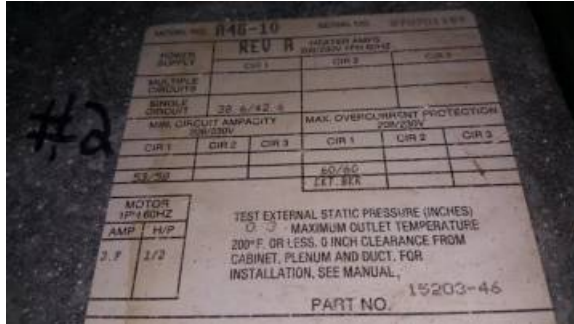
702.3 System Condition:

Visibly the air handler appears at the end of its life with excessive deterioration. Expect repair or replacements in the not too distant future. Estimated Cost to Correct: \$2000 - \$3000.

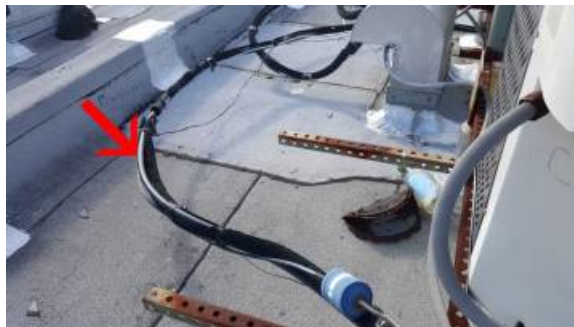
Refrigerant lines, The insulation wrap on the suction line to the condenser/compressor has deteriorated insulation noted. Properly install the missing insulation on the suction line at condenser / compressor. Estimated Cost to Correct: \$100 - \$150.

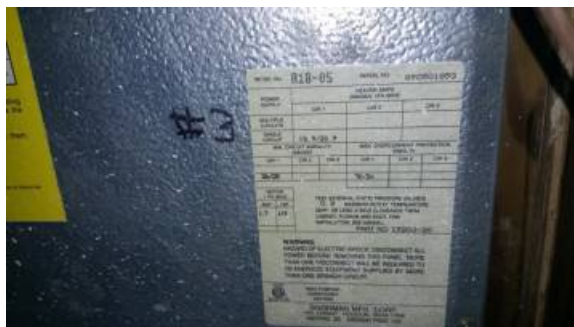
703.3 System Condition:

Not operational. Visibly the system appears at the end of its life with excessive deterioration. Expect repair or replacements in the not too distant future. Estimated Cost to Correct: \$5000- \$6500.

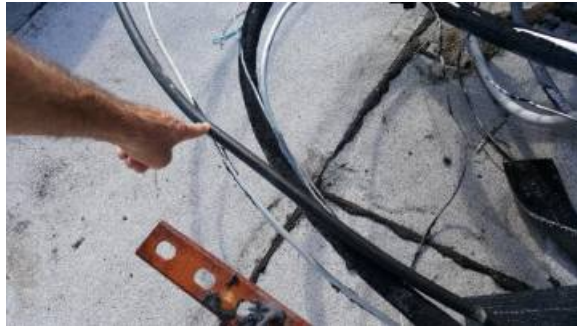
Refrigerant lines, The insulation wrap on the suction line to the condenser/compressor is deteriorated or has missing insulation. Properly repair or replace the missing/damaged insulation on the suction line at condenser / compressor. Estimated Cost to Correct: \$150 - \$250.

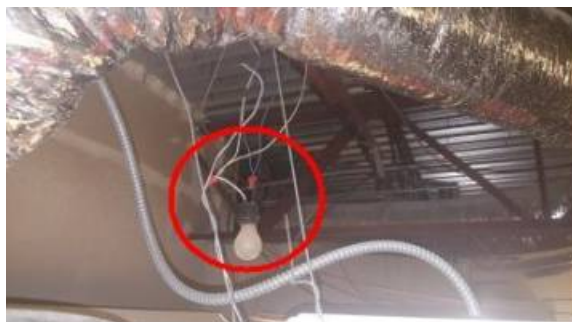
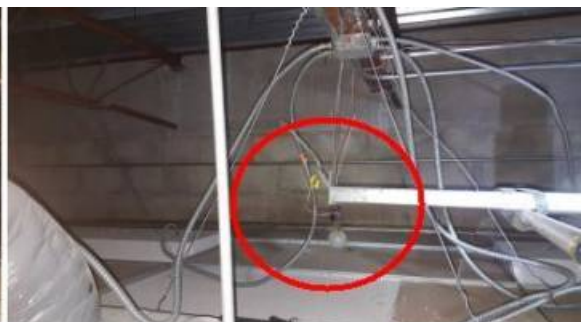
Entrance cables are copper and appear in good condition. Branch wiring consists of copper and appear in good condition. Some branch wiring located in Unit S has exposed wires and open junction boxes noted.. A safety / fire hazard exists. **Estimated cost to Correct = \$250 - \$500.**
