RE: REPORT

### REPORT SUMMARY

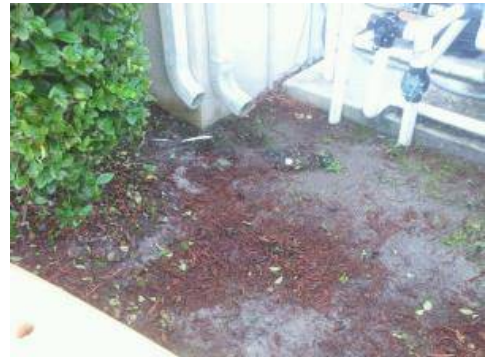
1. Site drainage appears adequate. Grade at foundation appears in good condition however, evidence of poor drainage is noted at left, rear corner of building. **Correction is needed to restore adequate drainage. Pitch grade away from building foundation..**

SITE DRAINAGE: Site drainage appears adequate. Grade at foundation appears in good condition however, evidence of poor drainage is noted at left, rear corner of building. **Correction is needed to restore adequate drainage. Pitch grade away from building foundation..**

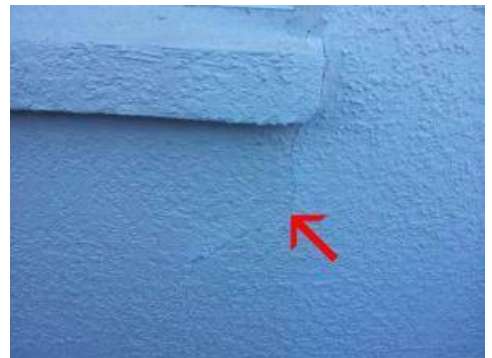
2. Stucco siding. Generally appears in good condition, Siding generally appears in good condition however, typical minor settlement/ expansion cracks are noted at the left side of house. These types of cracks will allow water to penetrate into wall. **Properly seal all exterior cracks to prevent water penetration, paint to match.**

TYPE & CONDITION: Stucco siding. Generally appears in good condition, Siding generally appears in good condition however, typical minor settlement/ expansion cracks are noted at the left side of house. These types of cracks will allow water to penetrate into wall. **Properly seal all exterior cracks to prevent water penetration, paint to match.**

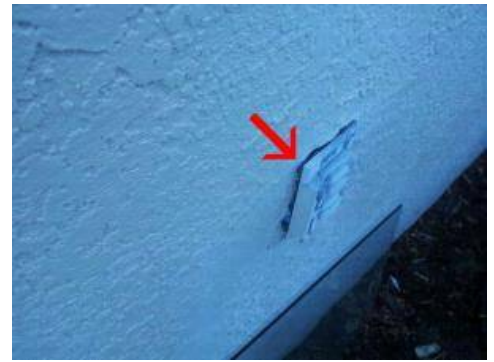
3. Small opening(s) noted at wall penetration where outlet is present at left side of house. This type of opening will allow water and insects to enter the home. **Properly seal any / all openings at wall penetrations.**

Small opening(s) noted at wall penetration where outlet is present at left side of house. This type of opening will allow water and insects to enter the home. **Properly seal any / all openings at wall penetrations.**

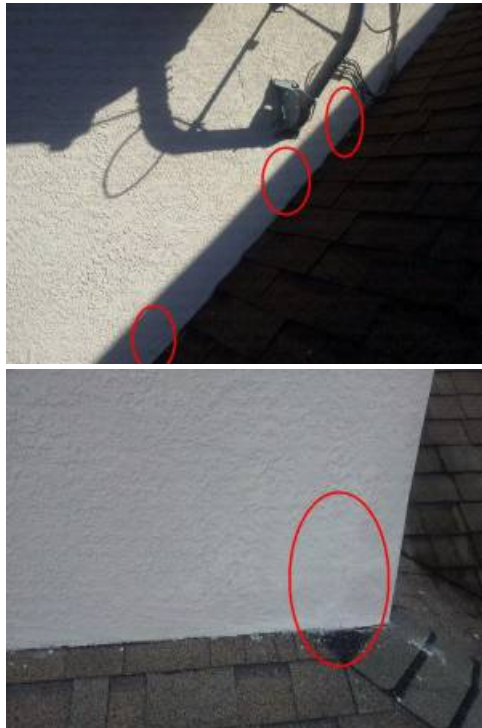
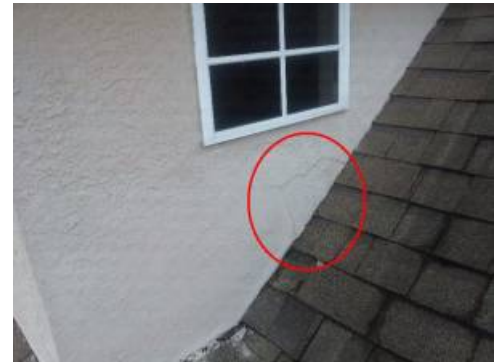
4. Stucco wall at rear of house at second story has expansion cracks. These types of cracks will allow water to penetrate into wall. **Properly seal all exterior cracks to prevent water penetration, paint to match.**

Stucco wall at rear of house at second story has expansion cracks. These types of cracks will allow water to penetrate into wall. **Properly seal all exterior cracks to prevent water penetration, paint to match.**

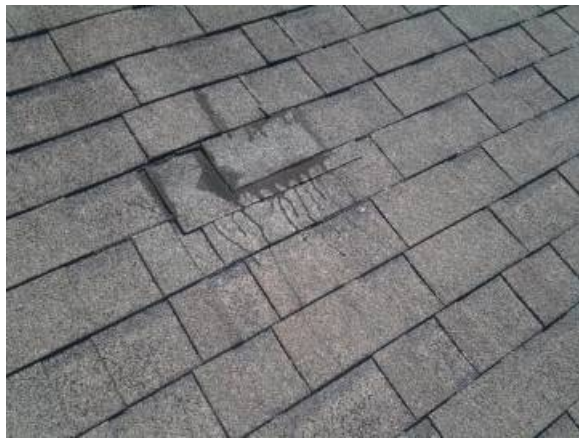
6. Minor roof leak noted at left side of house over dining room area. Evidence of past repair is noted at same location. **Have a licensed and insured roofing contractor provide further evaluation, repair estimates and repairs as needed.**

ROOF COVERING STATUS:	Generally the roof covering appears in fair condition.
ROOF COVERING STATUS #2:	Minor roof leak noted at left side of house over dining room area. Evidence of past repair is noted at same location. <b>Have a licensed and insured roofing contractor provide further evaluation, repair estimates and repairs as needed.</b>

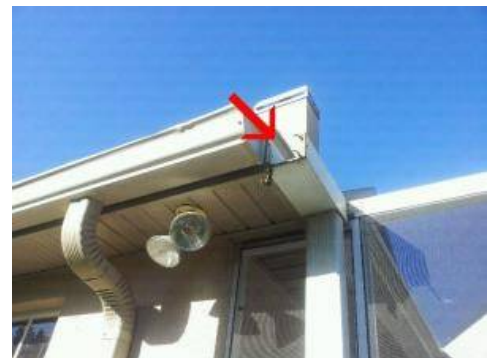
8. Missing gutter end cap(s) noted at left and right side of rear gutter. **Properly install gutter end cap to restore appropriate operation of gutter.**

Missing gutter end cap(s) noted at left and right side of rear gutter. **Properly install gutter end cap to restore appropriate operation of gutter.**

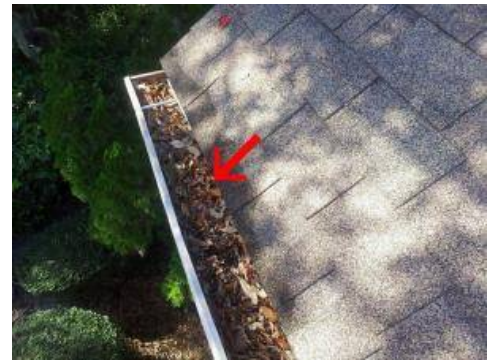
1. Debris noted in gutter is restricting drainage. **Properly remove all debris from gutter system to restore proper drainage.**

Debris noted in gutter is restricting drainage.  
Properly remove all debris from gutter system to  
restore proper drainage.

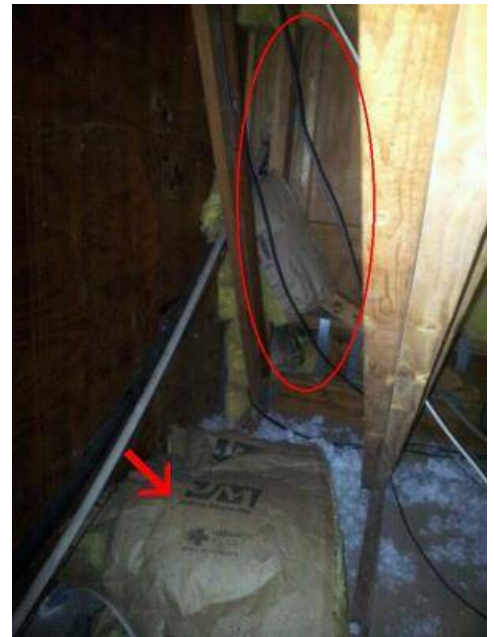
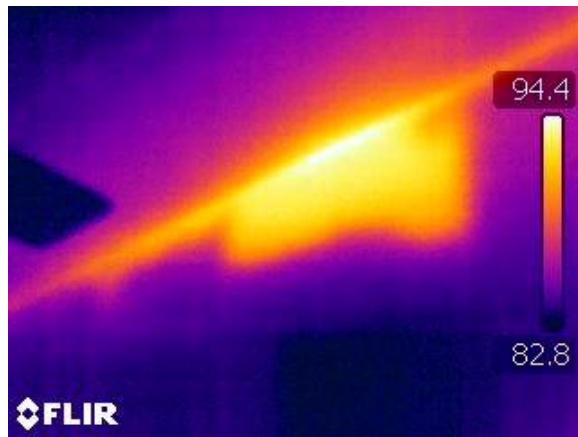
9. Insulation appears in good condition, Insulation appears in good condition however, a small section of the insulation covering knee wall(s) in garage attic has fallen away from wall. This condition is considered a hole in the insulative envelope of the attic space. Infrared thermal imaging indicates missing / fallen insulation ant knee wall at kitchen area. **Properly secure all loose / fallen insulation at knee walls in attic to provide a complete insulative envelope in attic space.**

Insulation appears in good condition, Insulation appears in good condition however, a small section of the insulation covering knee wall(s) in garage attic has fallen away from wall. This condition is considered a hole in the insulative envelope of the attic space. Infrared thermal imaging indicates missing / fallen insulation ant knee wall at kitchen area. **Properly secure all loose / fallen insulation at knee walls in attic to provide a complete insulative envelope in attic space.**

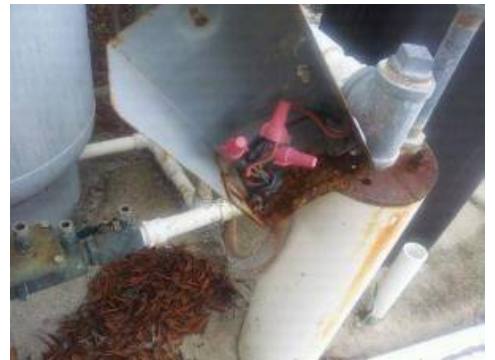
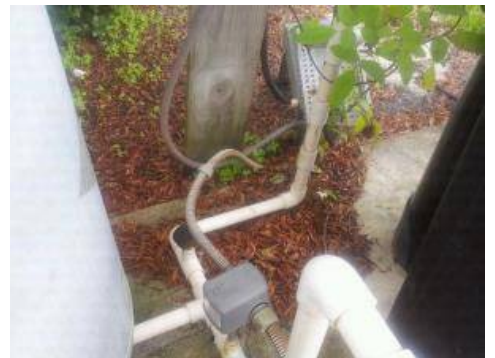
10. An improper junction box with exposed wires is noted at the top of the well casing. **Have a qualified and insured well contractor provide further evaluation and repairs.**

An improper junction box with exposed wires is noted at the top of the well casing. **Have a qualified and insured well contractor provide further evaluation and repairs.**

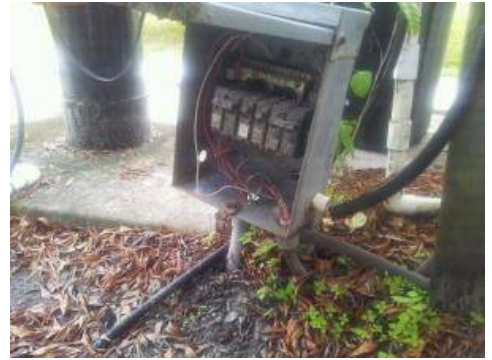
11. The sub panel is damaged and is missing the cover plate. A safety hazard is present. **Have a licensed and insured electrical contractor properly repair or replace the sub panel and install the missing cover plate.**

The sub panel is damaged and is missing the cover plate. A safety hazard is present. **Have a licensed and insured electrical contractor properly repair or replace the sub panel and install the missing cover plate.**

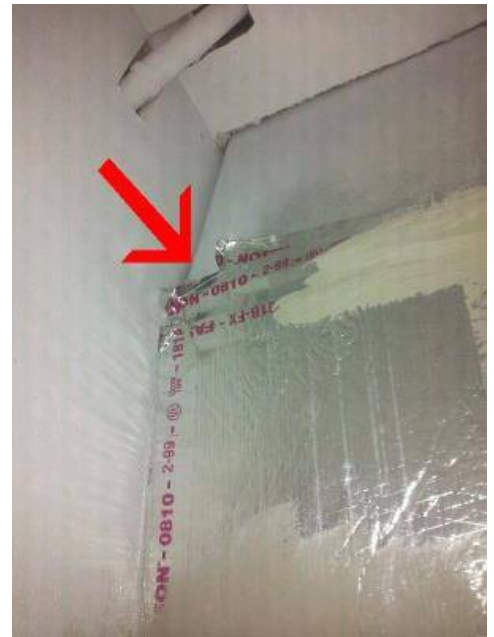
13. Ductwork appears in good condition however, air leaks are noted at main supply duct connection to the air handler. **Properly seal and, or tape or repair all leaking at main supply duct at air handler to prevent further leaking.**

Ductwork appears in good condition however, air leaks are noted at main supply duct connection to the air handler. **Properly seal and, or tape or repair all leaking at main supply duct at air handler to prevent further leaking.**

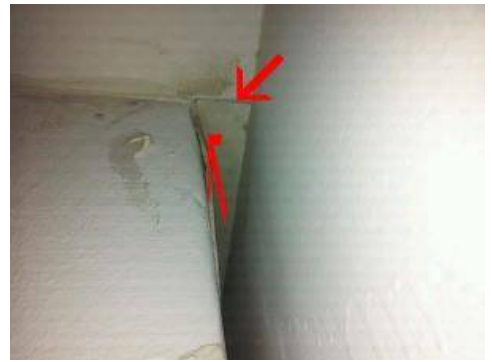
14. Drywall ceiling is open to the attic space allowing moist, un-conditioned air into the closet. **Properly repair the ceiling at the mechanical closet to prevent unconditioned air from entering.**

Drywall ceiling is open to the attic space allowing moist, un-conditioned air into the closet. Properly repair the ceiling at the mechanical closet to prevent unconditioned air from entering.

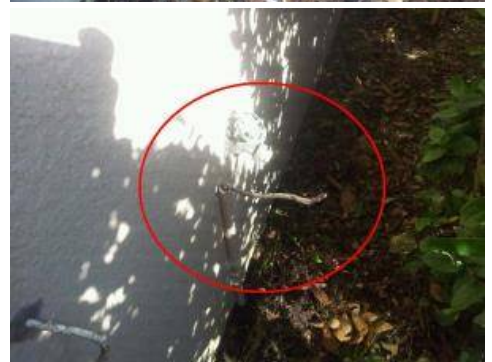
Properly connect the ground wire to the hose bib at the left side of house to restore adequate ground of the electrical system.

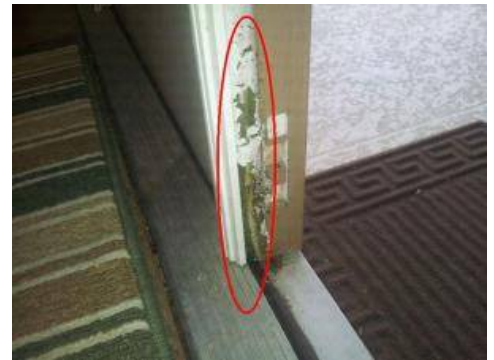
17. French doors, Appear in good condition. Weather-stripping at door has damage / deterioration noted. **Properly replace weather stripping to restore weather tightness at door.**

French doors, Appear in good condition. Weather-stripping at door has damage / deterioration noted. **Properly replace weather stripping to restore weather tightness at door.**

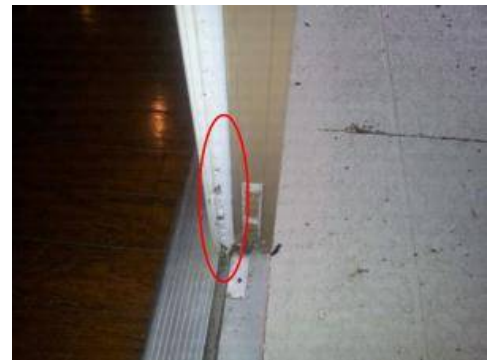
18. French doors, Appear in good condition. Weather-stripping at door has damage / deterioration noted. **Properly replace weather stripping to restore weather tightness at door.**

French doors, Appear in good condition. Weather-stripping at door has damage / deterioration noted. **Properly replace weather stripping to restore weather tightness at door.**

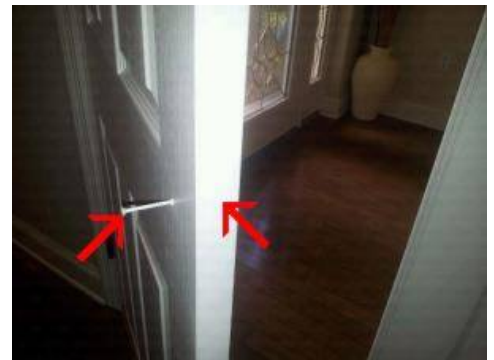
19. Appear in good condition however, missing door knob and hardware is noted at french doors to Office / Den. **Properly install the missing hardware to restore operating conditions to door.**

Appear in good condition however, missing door knob and hardware is noted at french doors to Office / Den. **Properly install the missing hardware to restore operating conditions to door.**

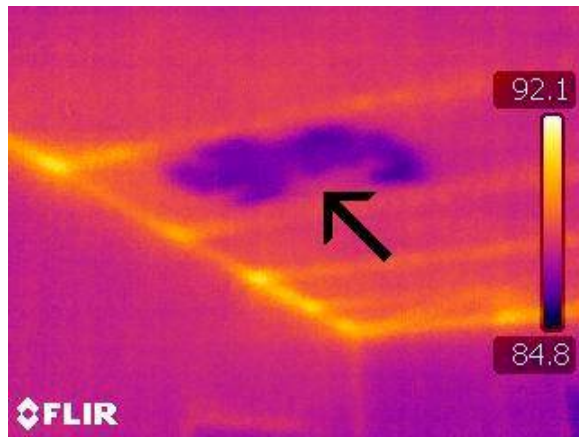
20. Drywall, Generally conditions appear good however, infrared thermal imaging identified moisture at ceiling of dining room caused by minor roof leak. **After the source of moisture has been adequately addressed then seal, prime and paint the ceiling to match existing.**

Drywall, Generally conditions appear good however, infrared thermal imaging identified moisture at ceiling of dining room caused by minor roof leak. **After the source of moisture has been adequately addressed then seal, prime and paint the ceiling to match existing.**

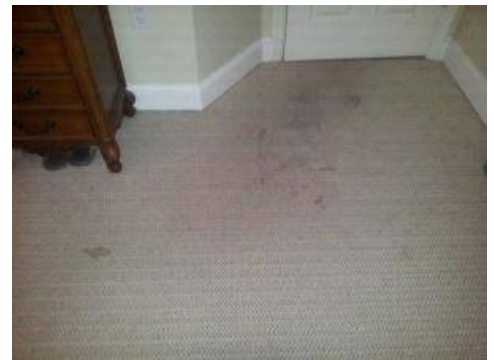
2. Carpet, Wood, and Tile. Flooring appears in good condition however, visible stains are noted at the master bedroom. **Properly repair or replace the damaged areas of flooring as needed.**

Carpet, Wood, and Tile. Flooring appears in good condition however, visible stains are noted at the master bedroom. **Properly repair or replace the damaged areas of flooring as needed.**

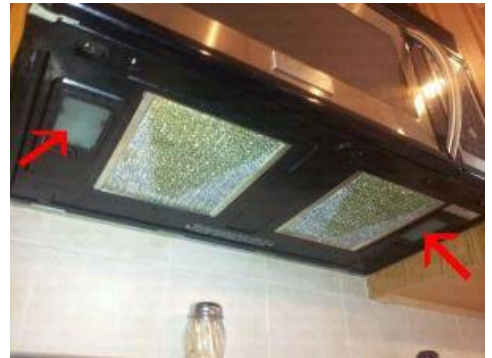
4. Exhaust is vented externally. Fan/Hood operational, Range hood light is not operational. Possible bad bulb? **Properly replace hood light bulb and test operation.**

Exhaust is vented externally. Fan/Hood operational, Range hood light is not operational. Possible bad bulb? **Properly replace hood light bulb and test operation.**

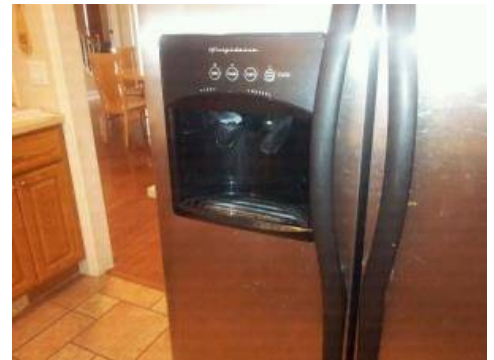
21. Unit is not operational at refrigerator door. **Have a qualified and insured service technician make further evaluation and repairs or replacements as needed to restore normal operation.**

Unit is not operational at refrigerator door. **Have a qualified and insured service technician make further evaluation and repairs or replacements as needed to restore normal operation.**

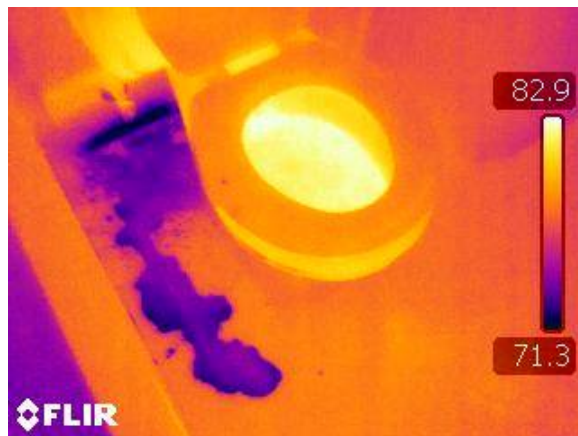
22. The water supply shut-off valve has leaking / damage noted. **Properly repair or replace the water supply shut-off valve to prevent further leaking.**

CONDITION OF SINK(S):	One sink present, Appears in good condition. Drain appears operational, Counters/cabinets appear in good condition.
VANITY CABINET & COUNTER TOPS:	Counter top(s) appear in good condition. Vanity cabinets appear in good condition..
CONDITION OF TOILET:	The water supply shut-off valve has leaking / damage noted. <b>Properly repair or replace the water supply shut-off valve to prevent further leaking.</b>

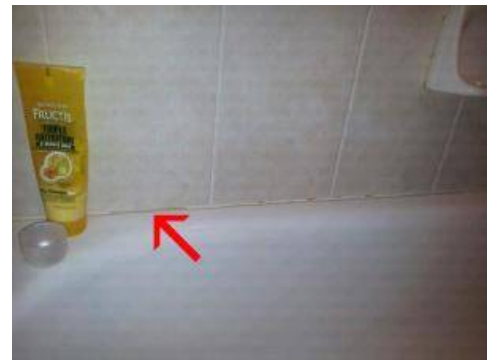
5. Shower areas appear to be in good condition. Open grout lines are noted at the shower walls allowing water to penetrate behind walls. Depending on length of exposure to water, non-visible damage to walls and tile may have occurred. **Properly re-grout and/or caulk immediately to prevent further water intrusion.**

Shower areas appear to be in good condition. Open grout lines are noted at the shower walls allowing water to penetrate behind walls. Depending on length of exposure to water, non-visible damage to walls and tile may have occurred. **Properly re-grout and/or caulk immediately to prevent further water intrusion.**

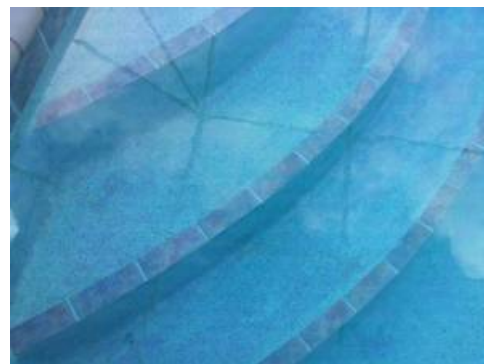
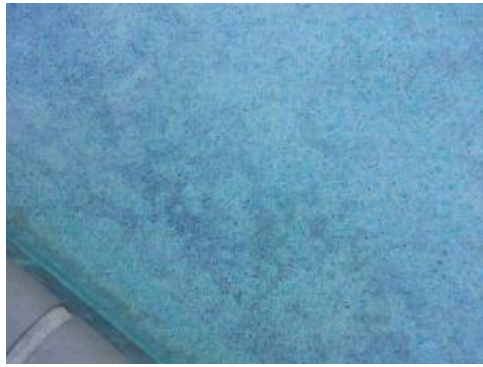
23. Staining and discoloration is noted throughout the pool surface. **Have a licensed and insured pool contractor provide further evaluation and repairs as needed.**

CONDITION: Staining and discoloration is noted throughout the pool surface. **Have a licensed and insured pool contractor provide further evaluation and repairs as needed.**

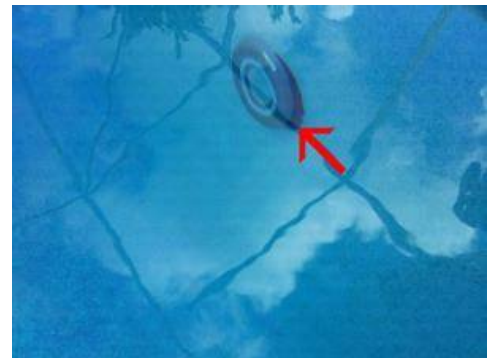
24. Pool light did not respond to light switch. **Properly replace the low voltage light bulb and re-test operation of pool light.** Light niche is loose in place, with re-attachment needed. **A licensed and insured pool contractor should be called to provide further evaluation and repairs as needed.**

Pool light did not respond to light switch. Properly replace the low voltage light bulb and re-test operation of pool light. Light niche is loose in place, with re-attachment needed. A licensed and insured pool contractor should be called to provide further evaluation and repairs as needed.

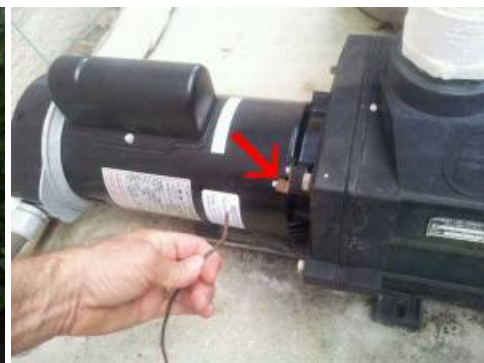
Appears operational and in good condition however ground wire is not connect at pump motor. Properly connect ground wire.

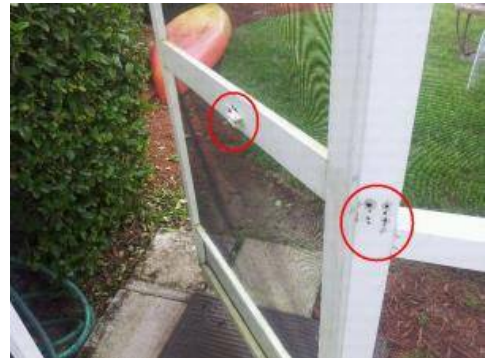
26. Screen door at left side has an automatic door closer assembly which is damaged / missing and does not operate properly. **Properly replace the damaged / missing automatic screen door closer to restore normal operation to the screen door.**

Screen door at left side has an automatic door closer assembly which is damaged / missing and does not operate properly. **Properly replace the damaged / missing automatic screen door closer to restore normal operation to the screen door.**

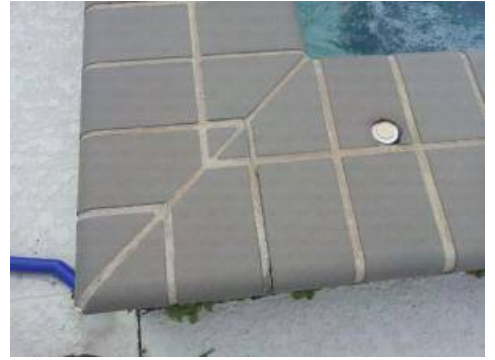
28. Minor cracks are noted at tile surround. **Properly re-grout cracks at tile.**

Minor cracks are noted at tile surround. Properly  
re-grout cracks at tile.
