Inspection Report

Report #: 6972

110 INTRODUCTION

At your request, we have performed a limited visual survey of specific construction components of the property located at 2902 59th Street West Bradenton FL. The date of the survey was 11/12/2015. Please see Section 200 of this report for a description of specific components which were assessed, and also Section 1200 for exclusions of this assessment.

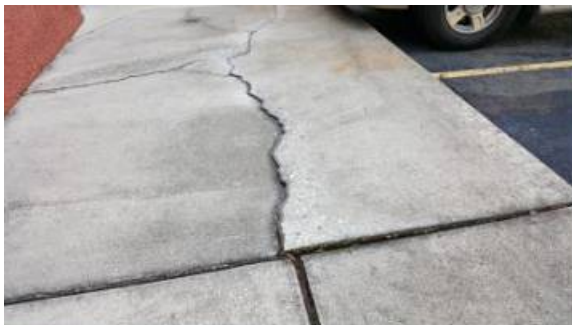
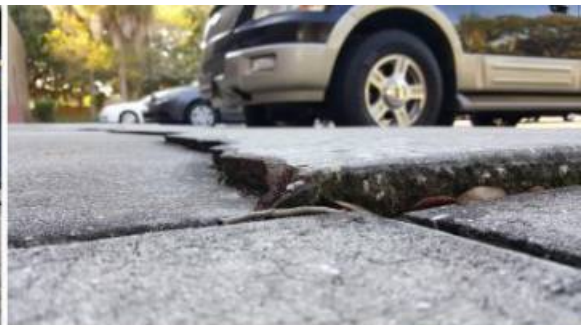
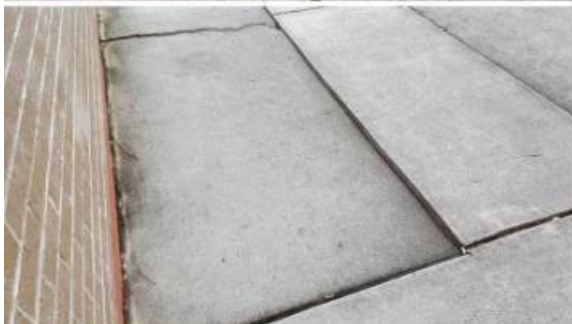
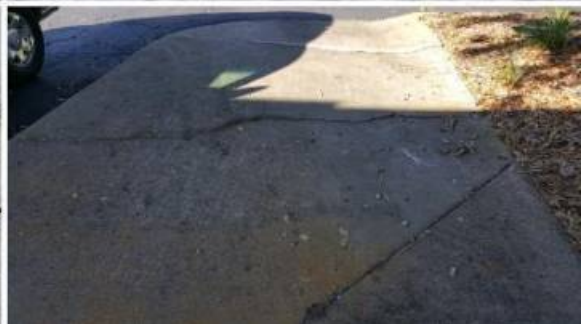
416 Flat Work

All walkways on the site are paved with concrete. Typical cracking of concrete was noted at the sidewalks around the perimeter of the property. Significant settlement cracks are noted at the sidewalks at the front and sides of the building. Significant safety / trip hazards are present. **Estimated Cost to Correct = \$2,000 - \$3,500.**

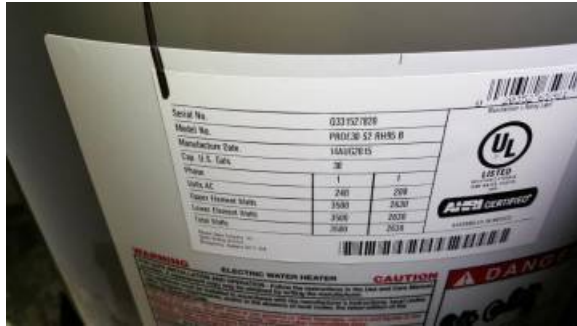
620.1 Water Heater #1:

Located in Unit B. Type: Electric. 30 gallon capacity. Estimated age is approximately less than one year as the unit was installed this year. Condition: New and in good operational condition.

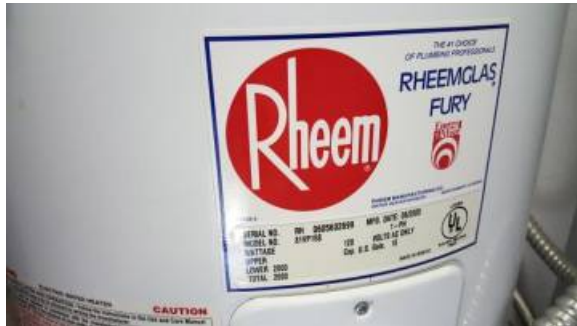
620.2 Water Heater #2:

Located in Unit C/D. Estimated age is approximately 10 years. Condition: Good operational condition.

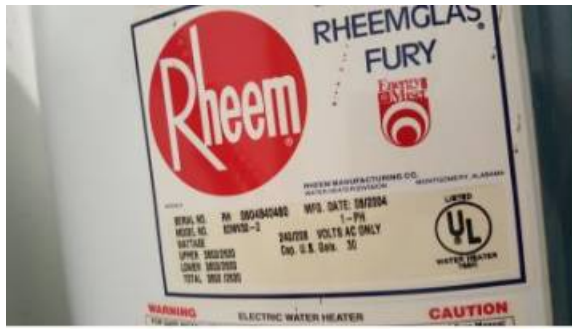
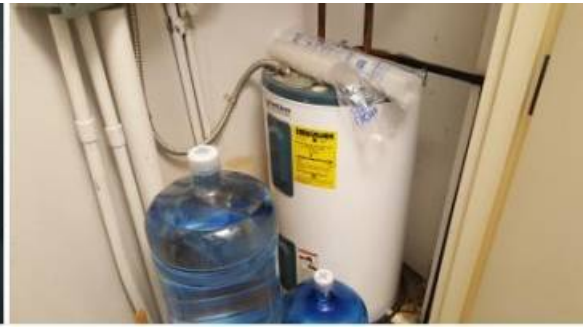
620.4 Water Heater #4:

Located in Unit T. Type: E, 30 gallon capacity. electric. Estimated age is approximately 11 years. Condition: Good operational condition.

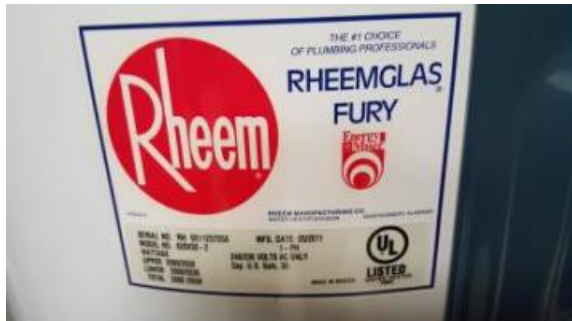
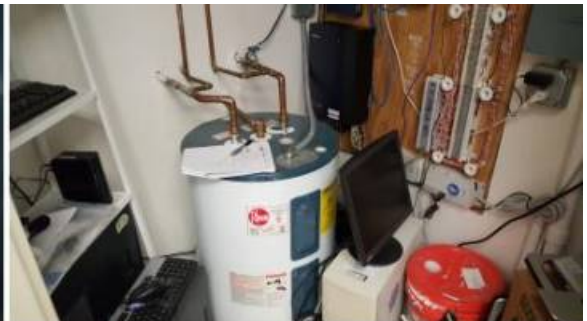
620.6 Water Heater #6:

Located in Unit M. Type: Electric. 30 gallon capacity. Estimated age is approximately 14 years. Condition: Good operational condition.

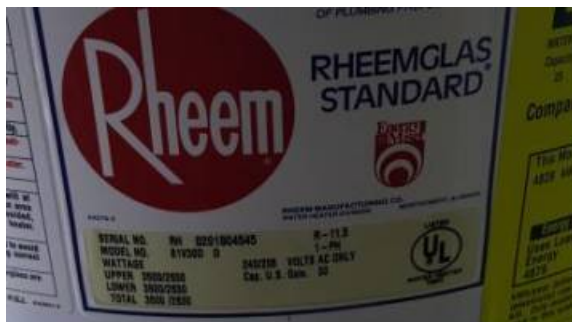
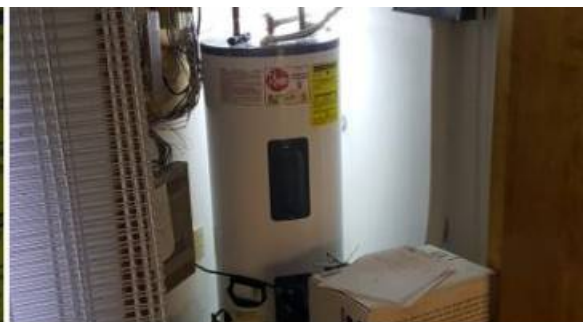
620.7 Water Heater #7:

Located in Unit Q. Type: Electric. 30 gallon capacity. Estimated age is approximately 14 years. Condition: Fair conditions. Unit is operational however, nearing the end of its useful life.

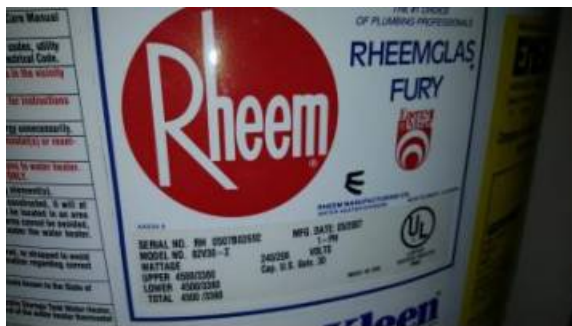
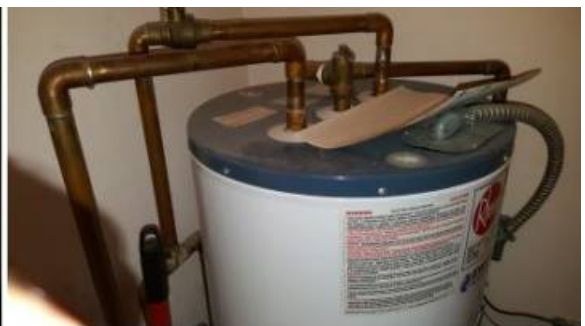
620.13 Water Heater #13:

Located in Unit E. Type: Electric. 30 gallon capacity. Estimated age is approximately 8 years. Condition: Good operational condition.

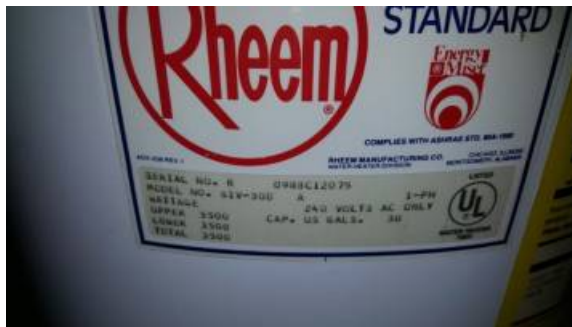
620.14 Water Heater #14:

Located in Unit R. Type: Electric. 30 gallon capacity. Estimated age is approximately 6 years.

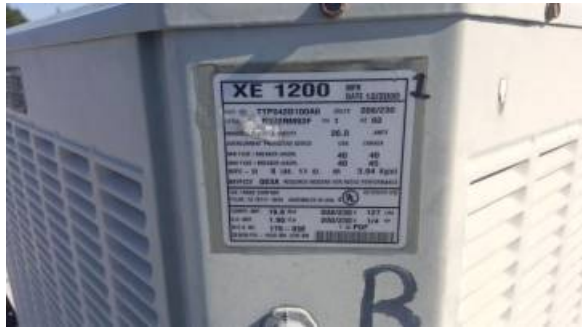
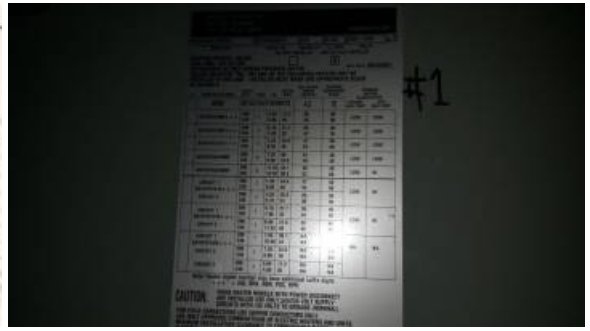
701.2 System age:

Estimated age of compressor is approximately 15 years and Estimated age of air handler is 15 years.

Visibly appears in operational condition. Evaporator coils have material build-up present. Temperature drop is approximately 12 degrees.

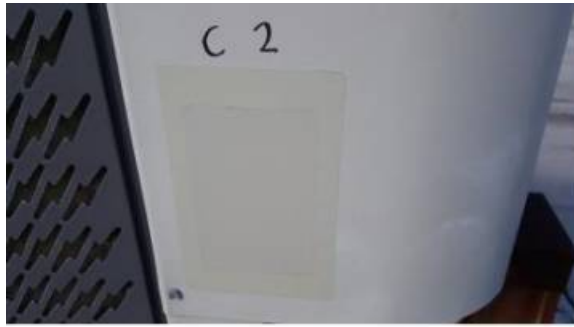
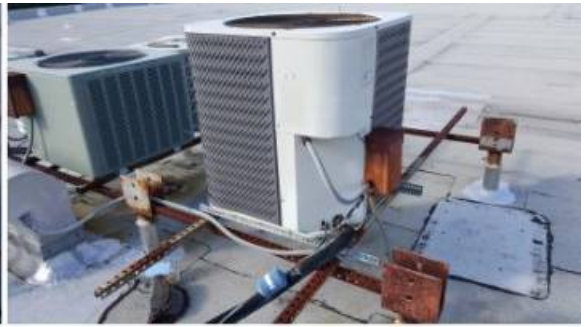
702.2 System age:

Unable to determine age as the serial numbers are not present / readable. Estimated age is 27 years.

Visibly the air handler appears at the end of its life with excessive deterioration. Expect repair or replacements in the not too distant future. Estimated Cost to Correct: \$2000 - \$3000.

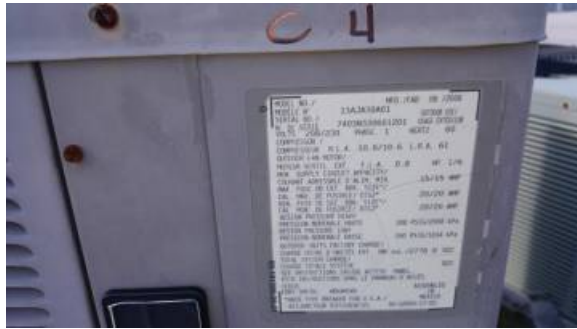
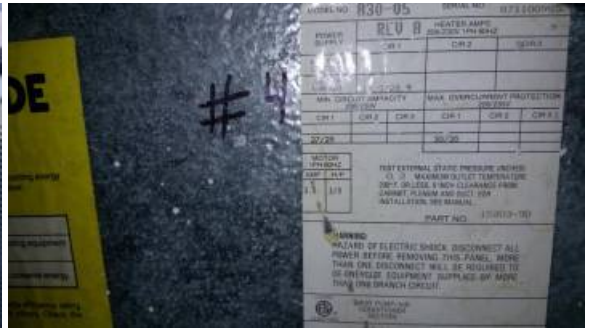
704.2 System age:

Estimated age of compressor is approximately 9 years. and Estimated age of air handler is 9 years..

Temperature drop is approximately 10 degrees.

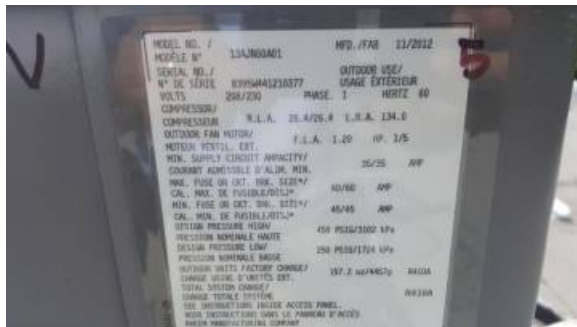
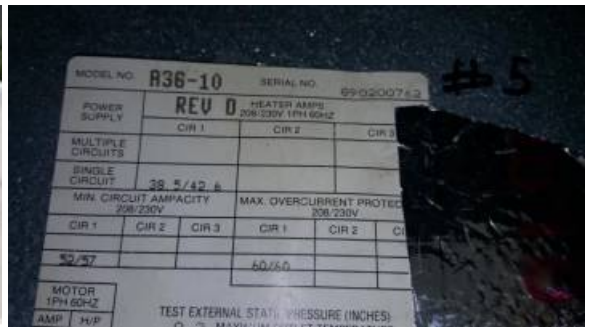
705.2 System age:

Estimated age of compressor is approximately 3 years. and Estimated age of air handler is 26 years.

Visibly appears in fair condition with minor wear air handler. Visibly appears in operational condition. Temperature drop is approximately 14 degrees. The air handler is older than its designed service life. Expect to replacement in the not too distant future. Cost to Correct \$2000 - \$3000.

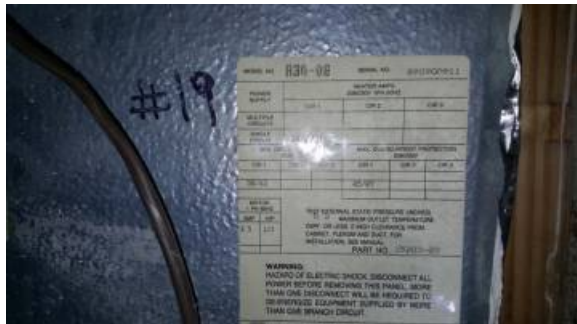
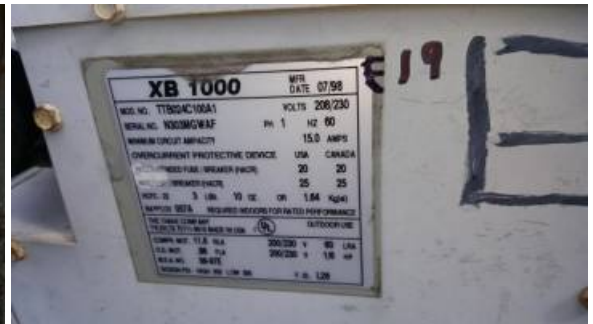
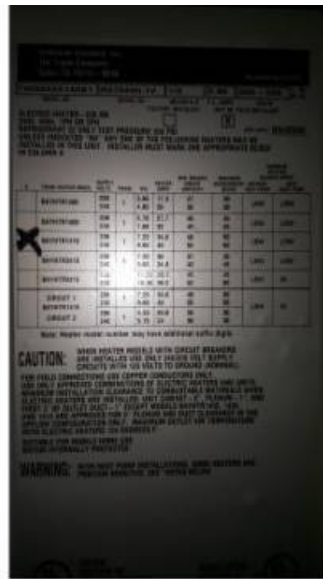
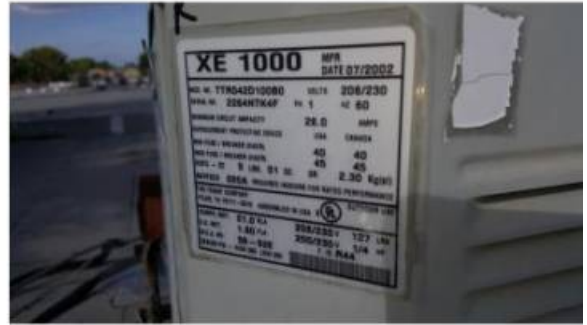
Estimated age of compressor is approximately 26 years. and Estimated age of air handler is and 17 years..

723.3 System Condition: Visibly appears in operational condition.

723.4 System Components: Appear in good condition.

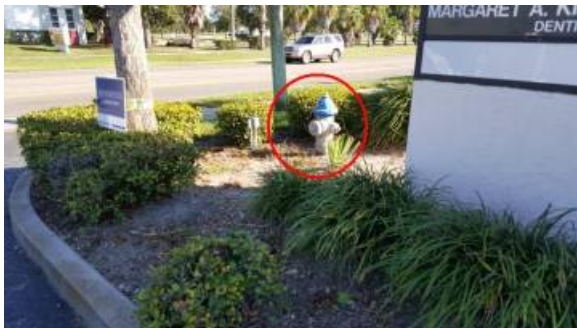
945 Fire Hydrants

Two fire hydrants are present at the perimeter of the property.

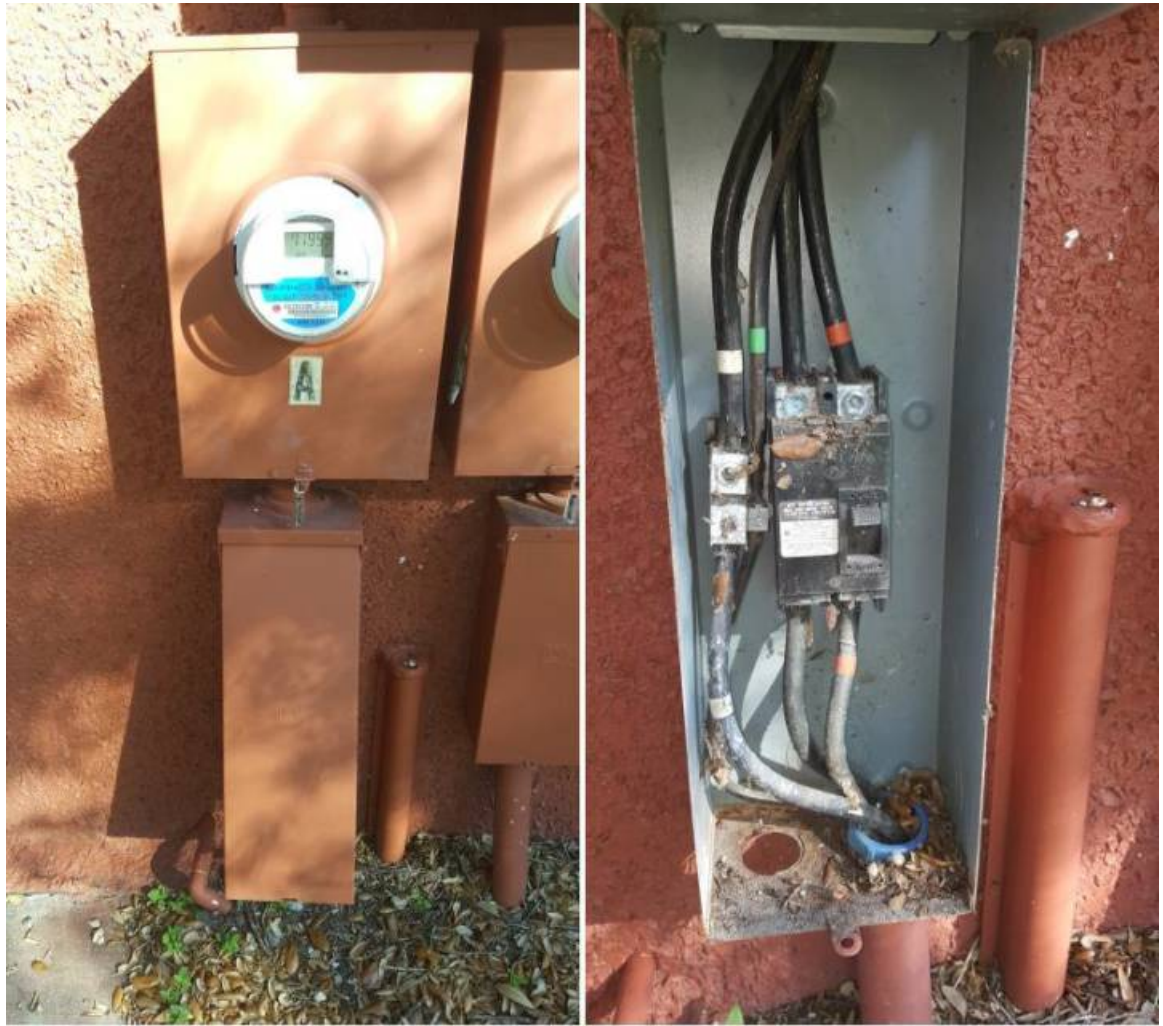
SERVICE DISCONNECT:

Located at exterior, rear of building. 200 Amps.

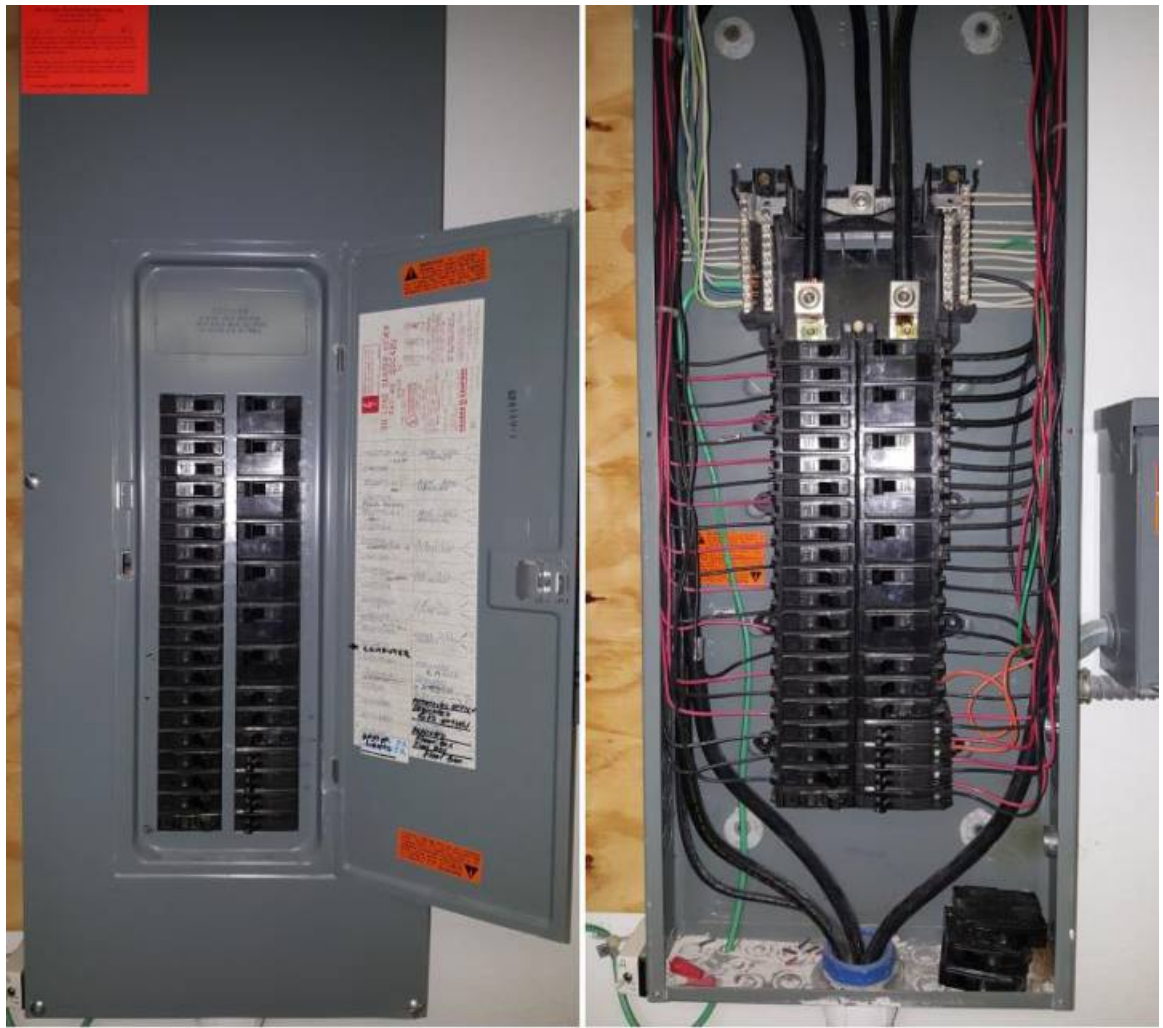
SUB PANEL:

Circuit and wire sizing correct so far as visible, Grounding system is present.
Circuit and wire sizing correct so far as visible, Grounding system is present.

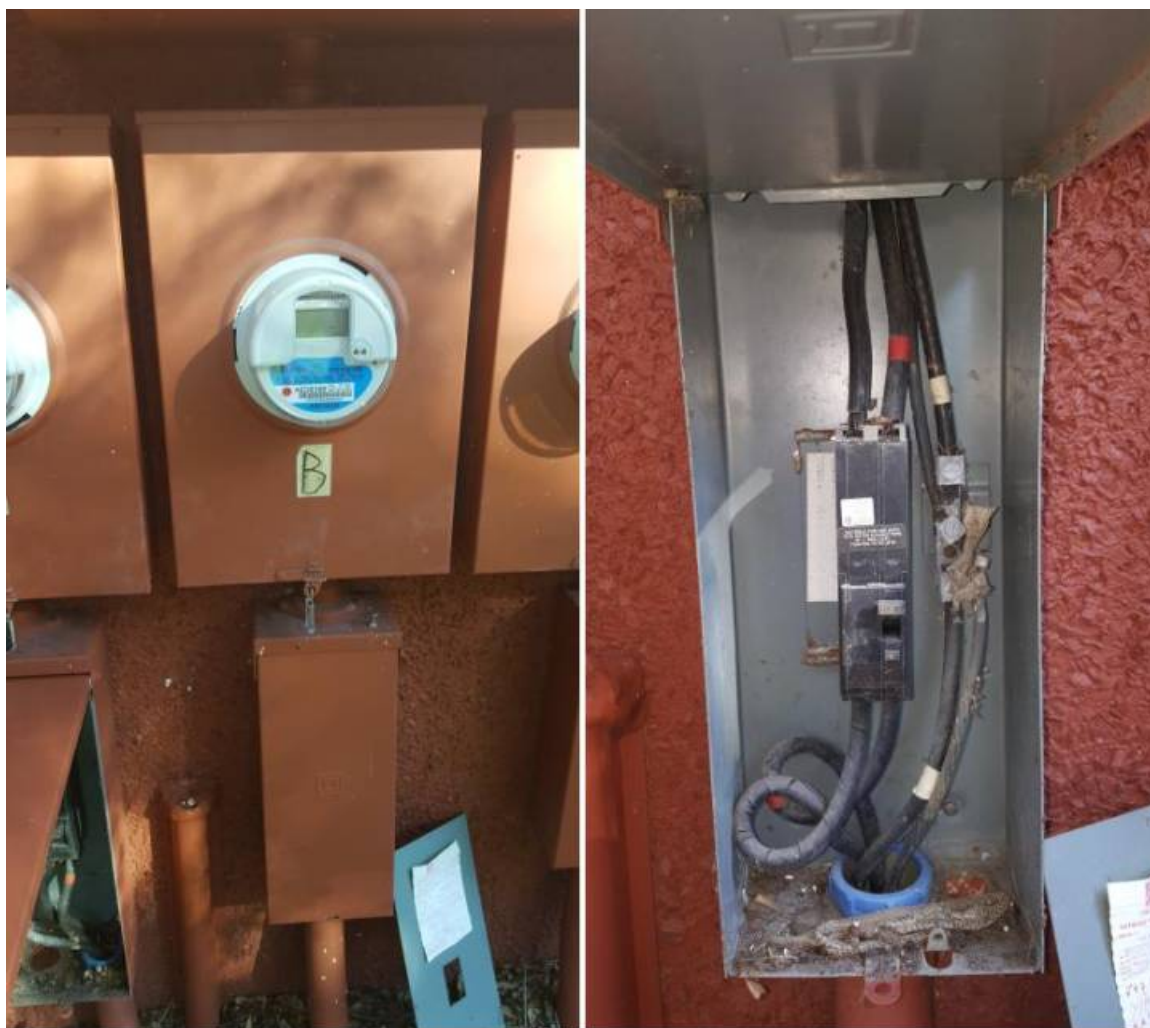
SERVICE DISCONNECT:

Located at exterior, rear of building. 200 Amps.

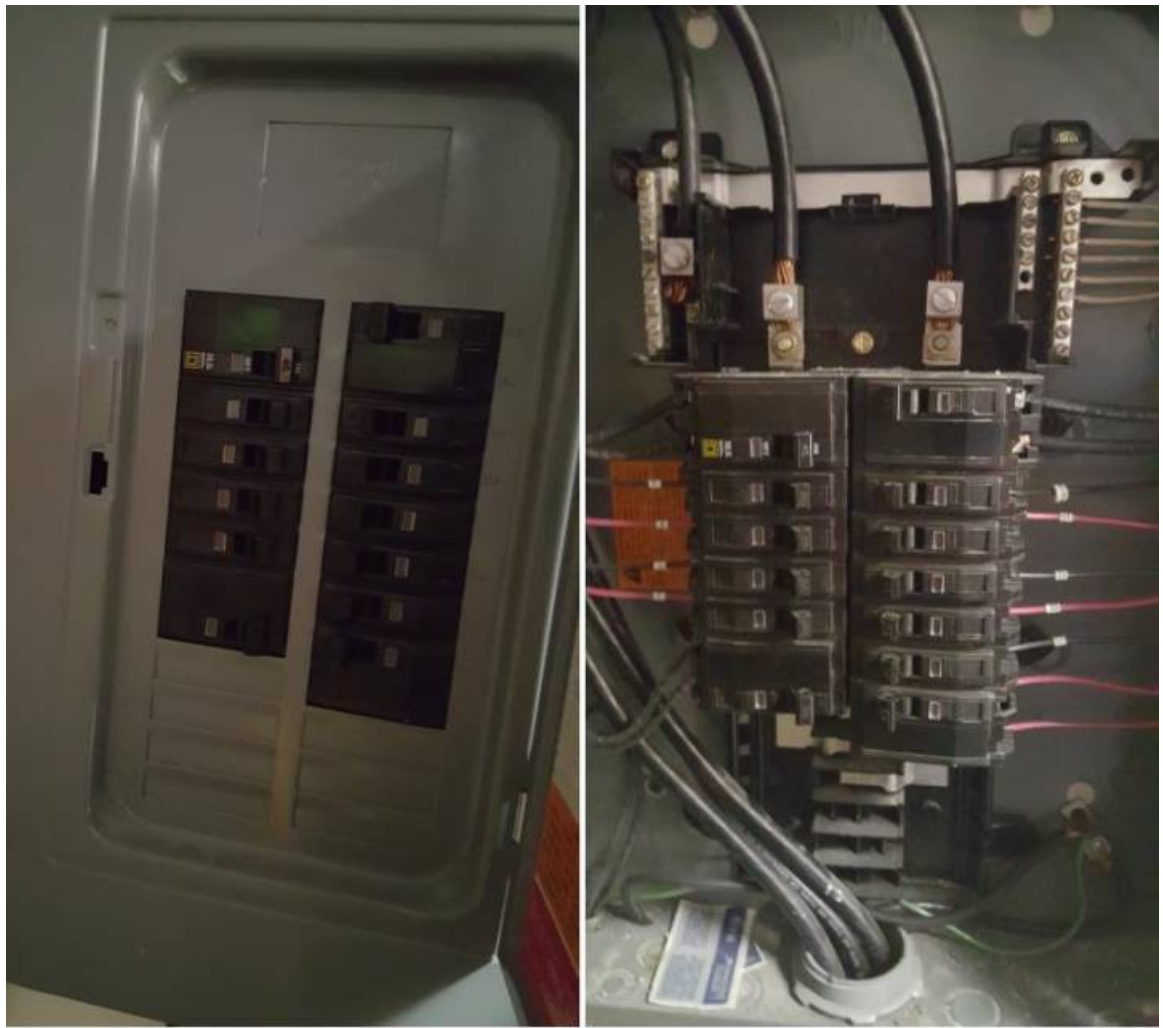
SUB PANEL:

Located at interior closet. Panel consists of circuit breakers. Circuit and wire sizing correct so far as visible. Grounding system is present.

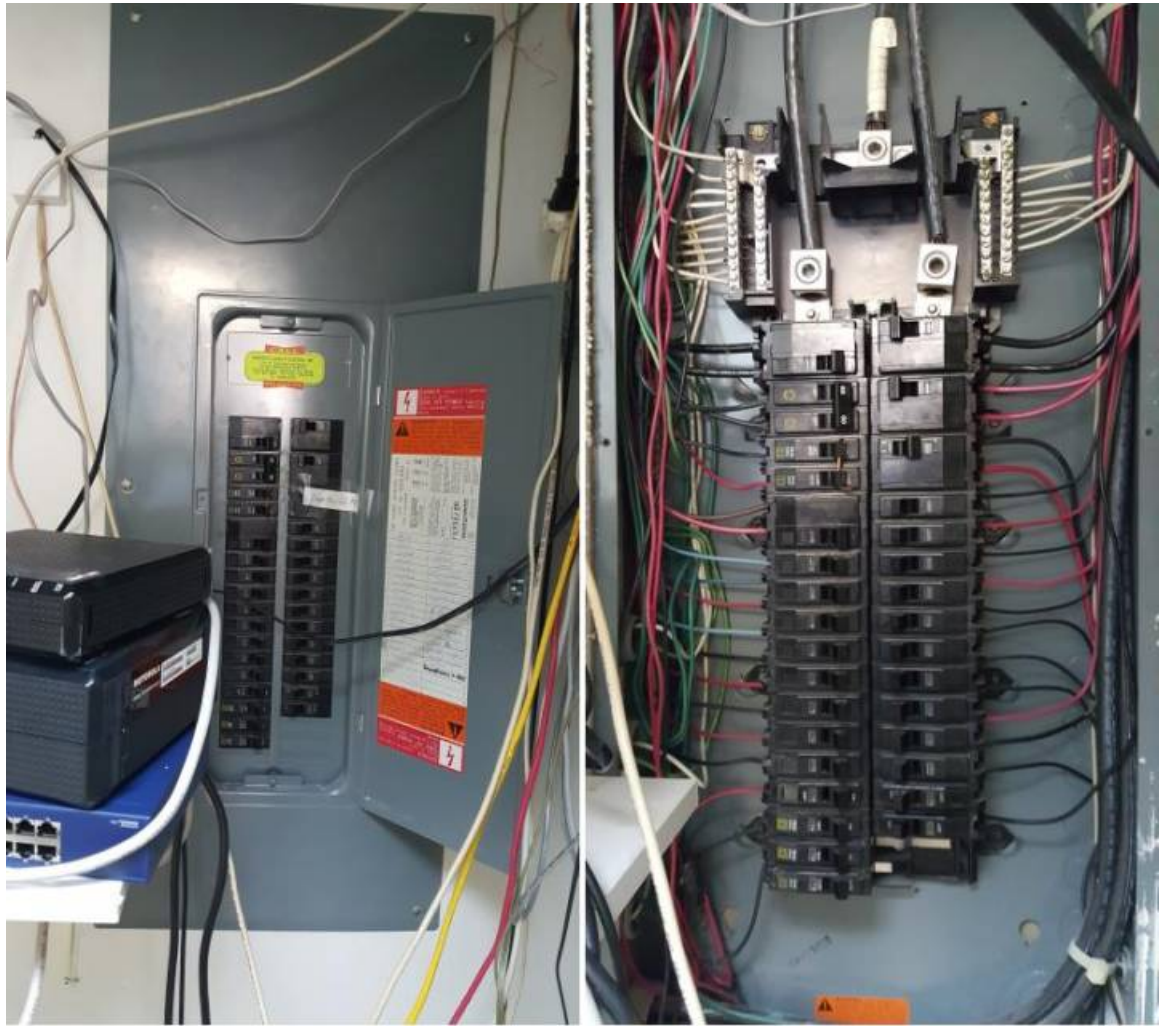
SERVICE DISCONNECT:

Located at exterior, rear of building. 125 Amps.

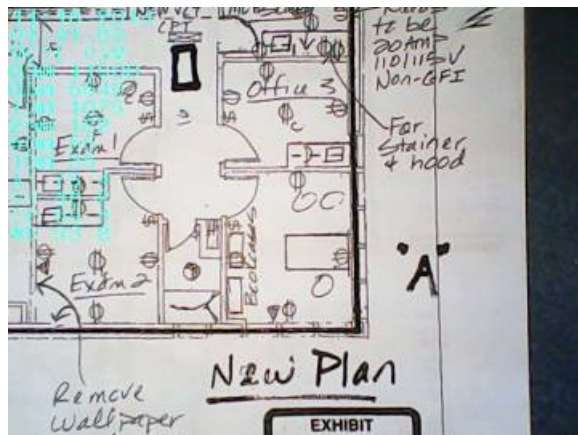
UNIT A:

Particle Count Sampling: Two particle counts conducted.

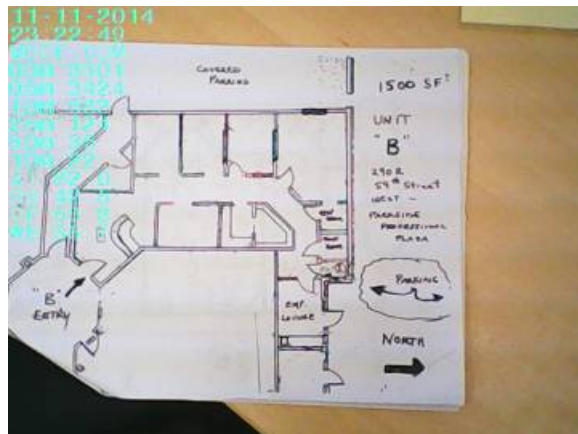
UNIT B:

Particle Count Sampling: One particle count conducted.

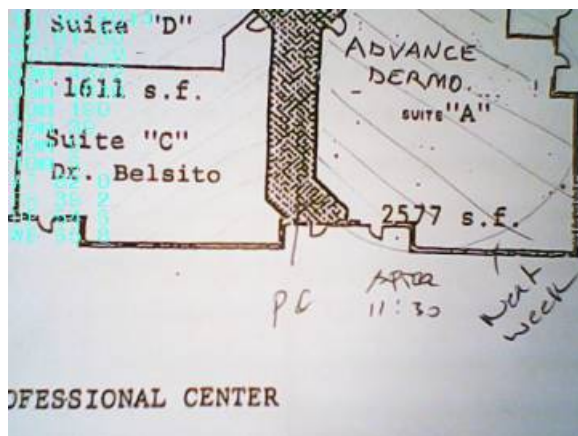
UNIT C:

Particle Count Sampling: One particle count conducted.

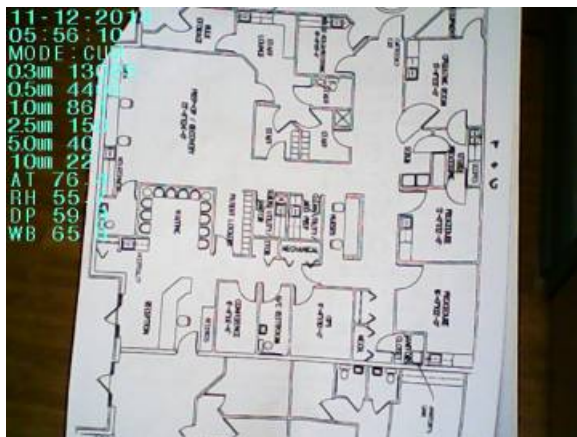
UNIT F & G:

Particle Count Sampling: One particle count conducted.

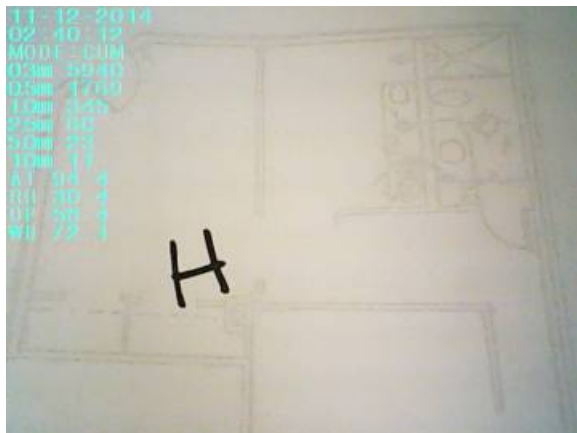
UNIT H:

Particle Count Sampling: One particle count conducted.

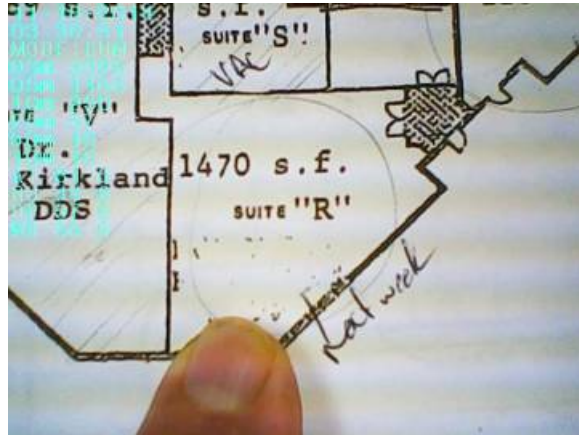
UNIT R:

Particle Count Sampling: One particle count conducted.

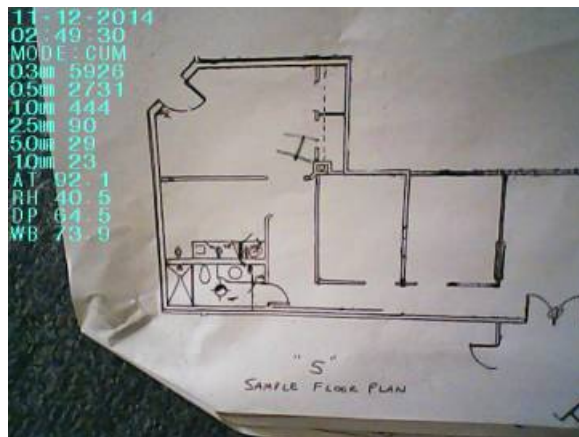
UNIT S:

Particle Count Sampling: One particle count conducted.

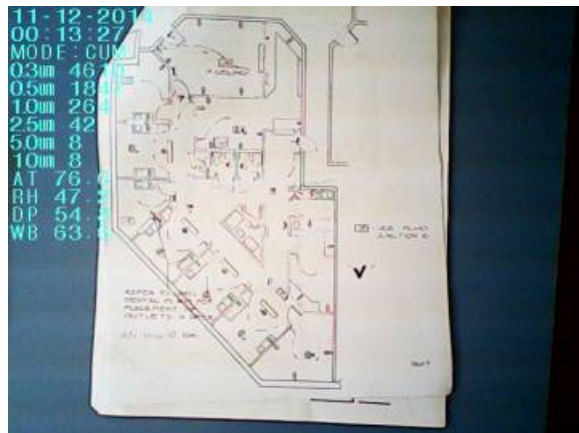
UNIT V:

Particle Count Sampling: One particle count conducted.
