RE: REPORT

### REPORT SUMMARY

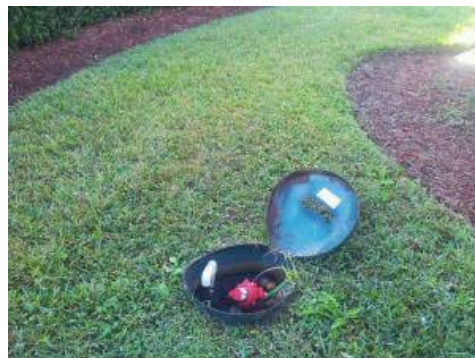
### UTILITY SERVICES:

WATER SOURCE: Private.  
SEWAGE DISPOSAL: Private septic system.  
UTILITIES STATUS: All utilities on. An underground fuel tank is noted at left side of property however, no fuel is present.

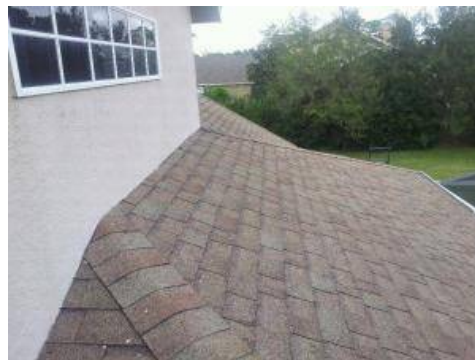
STYLE:	Gable roof with hips.
TYPE:	Dimensional, asphalt compositional shingles.
ROOF ACCESS:	Viewed from roof edge on ladder.
ESTIMATED AGE:	Estimated age of roofing system is approximately 15 years.
ESTIMATED USEFUL LIFE:	The estimated remaining useful life of roof covering is three to five years.

ROOF COVERING STATUS:	Generally the roof covering appears in fair condition.
ROOF COVERING STATUS #2:	Minor roof leak noted at left side of house over dining room area. Evidence of past repair is noted at same location. <b>Have a licensed and insured roofing contractor provide further evaluation, repair estimates and repairs as needed.</b>

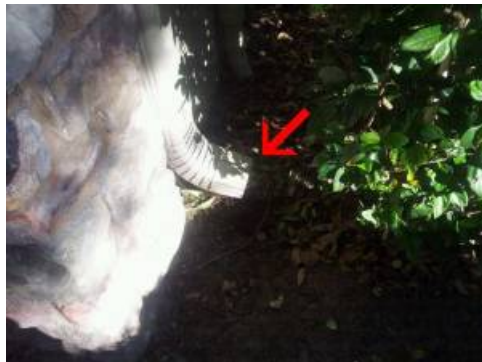
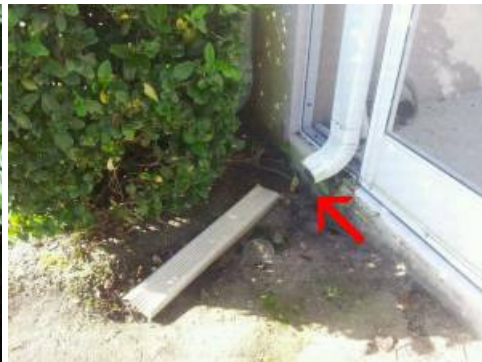
**GUTTER CONDITION:**

Downspout extension pipes are missing at right side of house causing soil washout near building foundation. **Properly install any missing downspout extension pipes and route extension pipes away from the building foundation.**

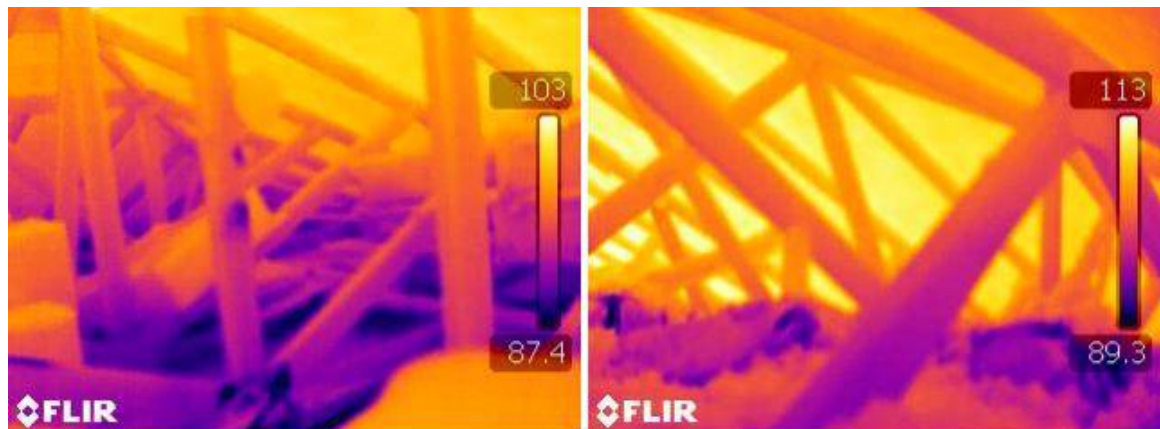
Generally, the visible areas of the attic appear in good condition.

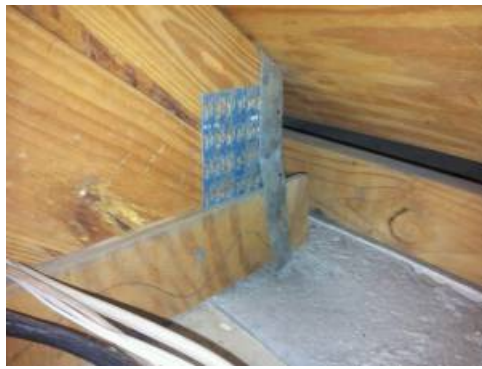
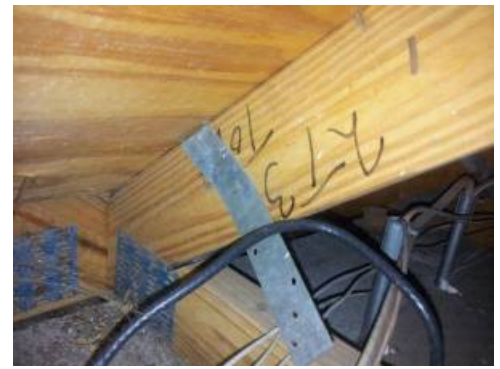
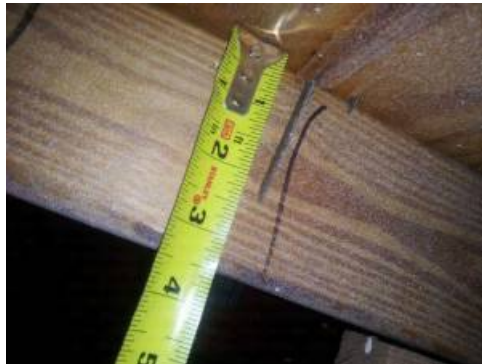
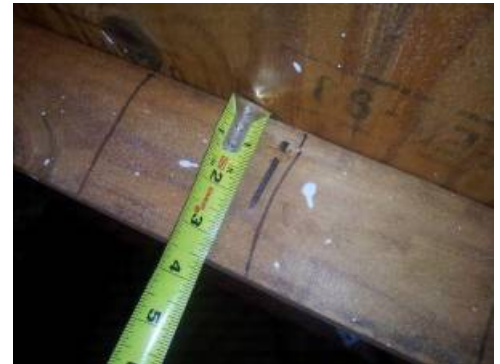
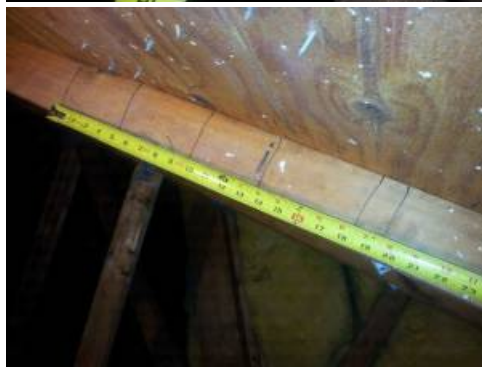
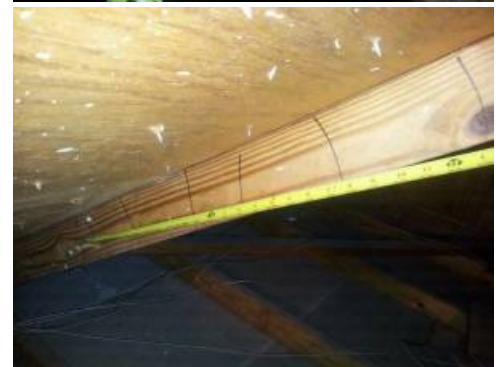
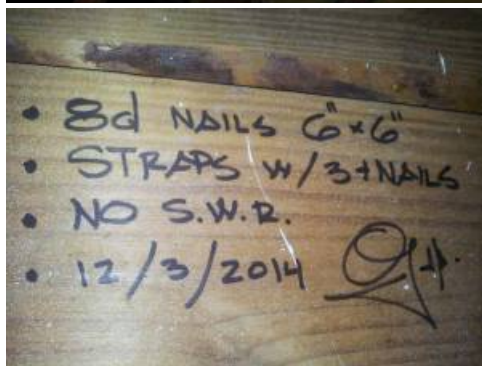
ATTIC / ROOF STRUCTURE #1: Attic structure generally appears in good condition, Roof decking is attached with 2 1/2" nails spaced 6" inches in the field and 6" inches on the edges. The roof structure is secured with hurricane straps.

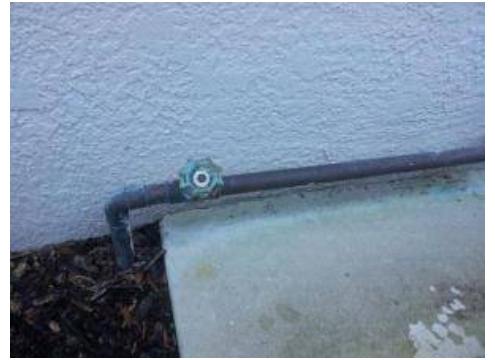
**MAIN SHUT OFF:**

Located at left side of house, appears in good condition.

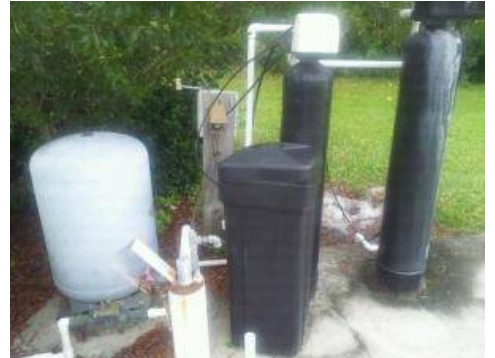
**PUMP TYPE:**

Submersible with water treatment system present. The water treatment system is not within the scope of a general home inspection. It is highly recommended to have the water treatment system evaluated by a qualified and insured water treatment company.

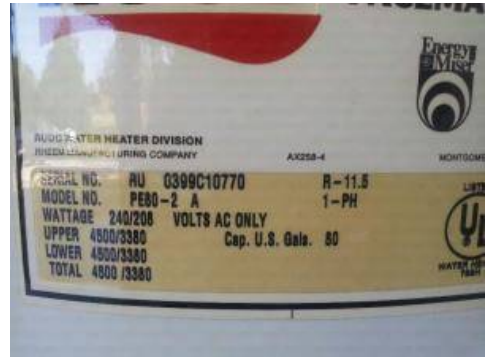
**WATER HEATER:**

**LOCATION:** Located in garage.  
**TYPE:** Electric.  
**ESTIMATED AGE:** Estimated age from manufacture date is approximately 15 years.

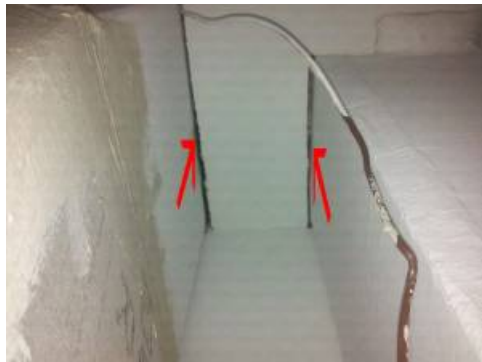
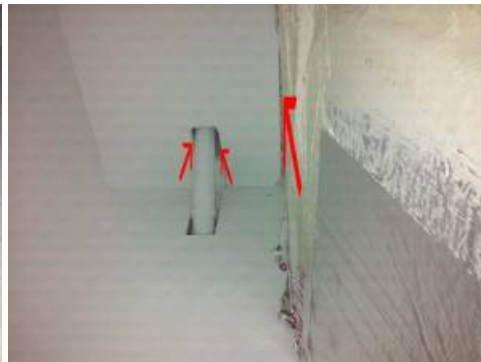
### MECHANICAL CLOSET:

Drywall ceiling is open to the attic space allowing moist, un-conditioned air into the closet. **Properly repair the ceiling at the mechanical closet to prevent unconditioned air from entering.**

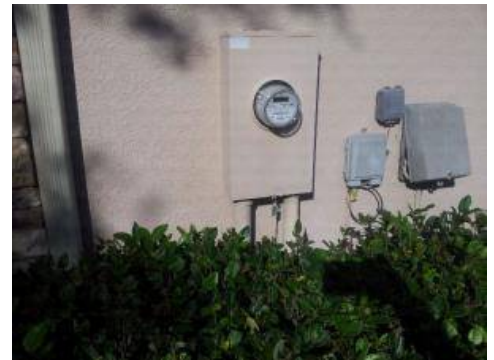
Service is underground, 110/220 Volt, In conduit,  
Appears in good condition.

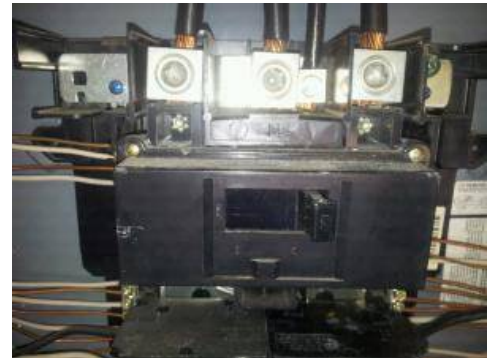
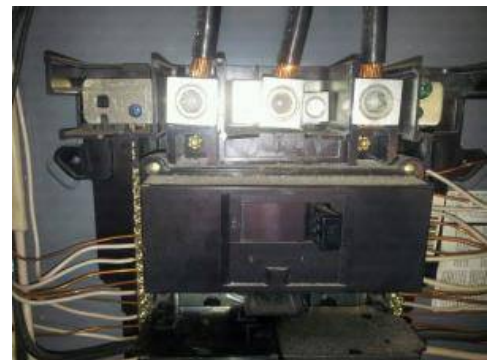
150 Amps.

Appears operational and in good condition.

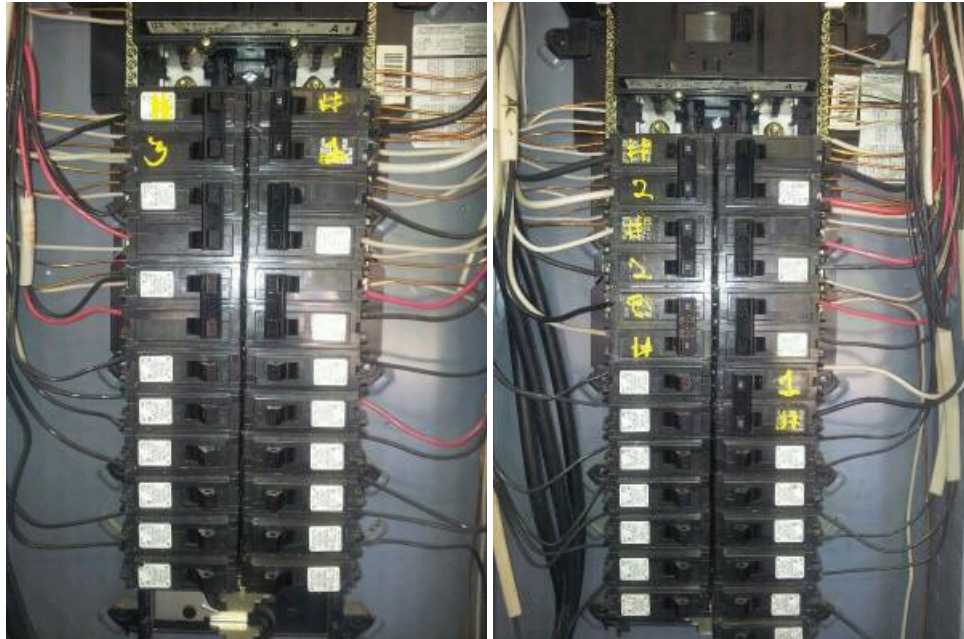
CONDITION: Circuit and wire sizing correct so far as visible, Grounding system is present.

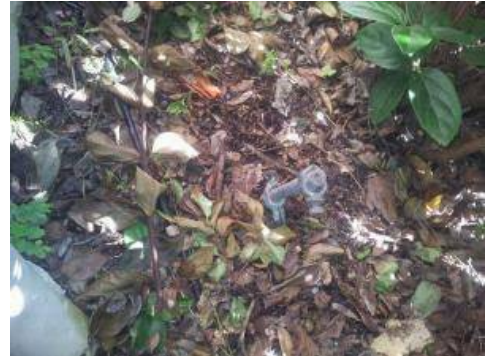
Grounding system consists of ground rod, clamp and ground wire and appears in good condition.

Ground wire for grounding system is not connected to the water system at the right side of the house.

Properly connect the ground wire to the hose bib at the left side of house to restore adequate ground of the electrical system.

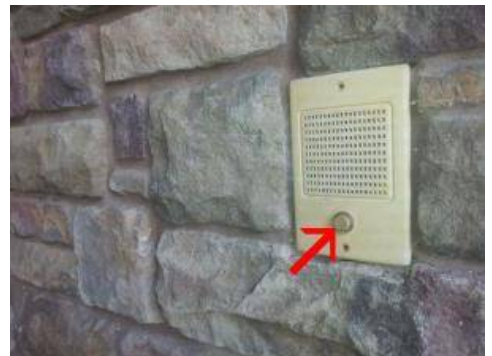
Appears in good condition, Doorbell does not function properly. Properly repair or replace door bell.

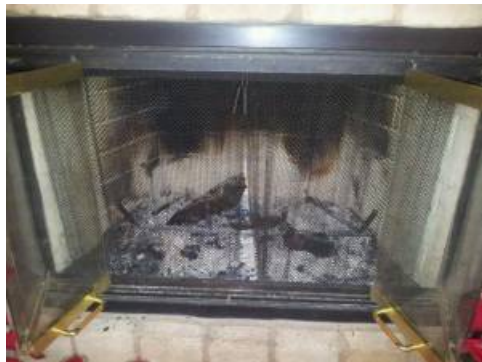
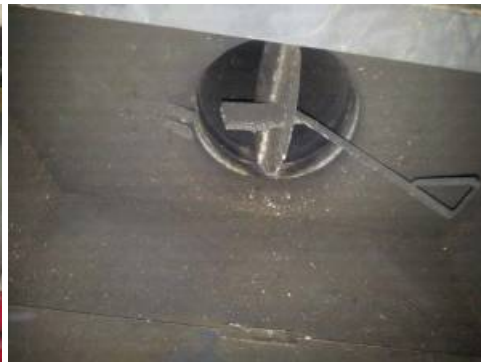
Fireplace located in living room, is a prefabricated metal unit. An insert is installed. Damper is operational. Spark arrestor appears in good condition. Fireplace is in need of cleaning. Recommend cleaning fireplace before use.

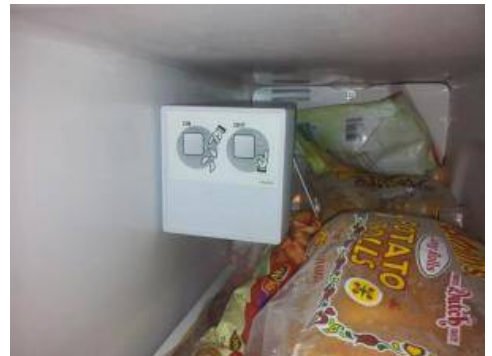
The ice maker was not on at time of inspection. As a result it was not possible to fully test Ice maker. It is recommended the ice maker be operational for at least 24 hours prior to testing operation. Properly test ice maker prior to closing.

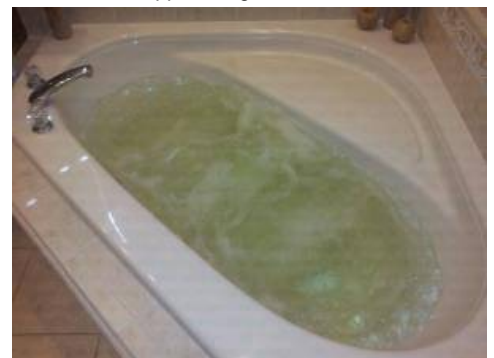
Spa tub appears in good operational condition. GFCI(Ground Fault Circuit Interrupter) safety device is present and operational.

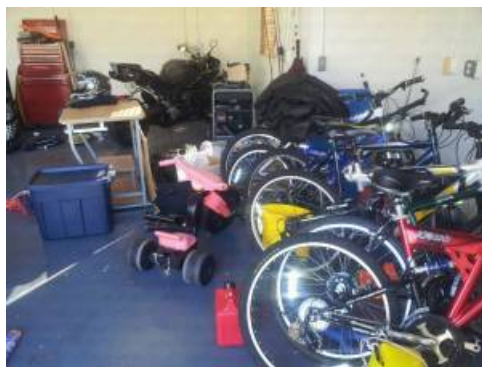
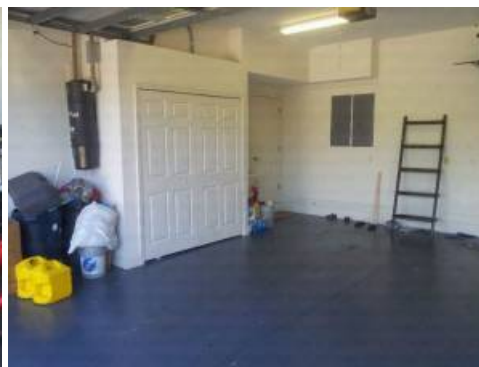
The garage was not fully inspected due to stored items which restrict viewing of the garage and its components.

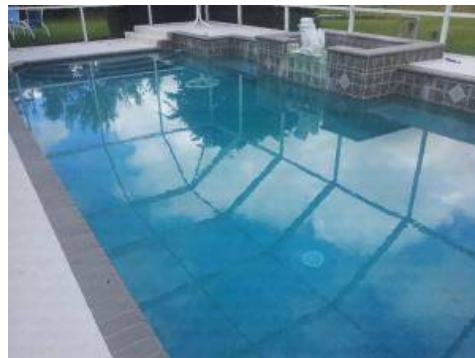
TYPE: Concrete in-ground pool with quartz surface.

CONDITION: Staining and discoloration is noted throughout the pool surface. **Have a licensed and insured pool contractor provide further evaluation and repairs as needed.**

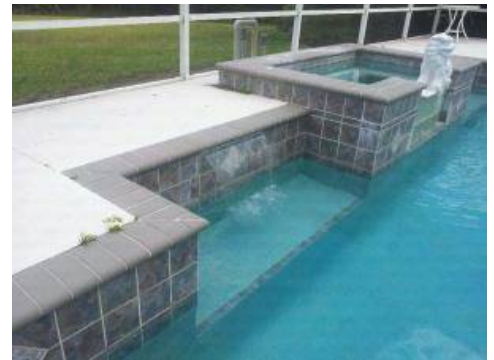
Water features appear in operational condition.

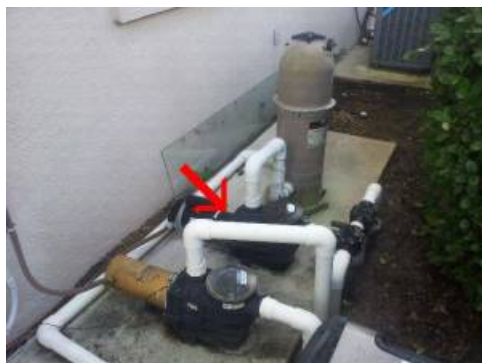
Appears operational and in good condition however ground wire is not connect at pump motor. Properly connect ground wire.

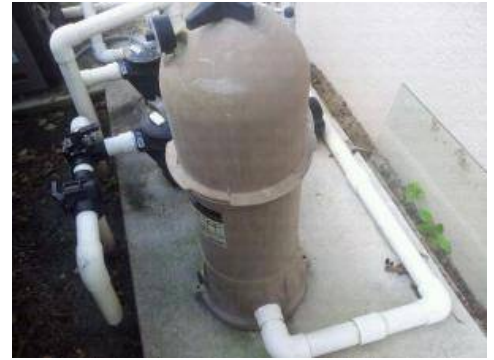
No visible leaking is noted.  
Appears in good condition.  
Cartridge, Appears in operational condition.

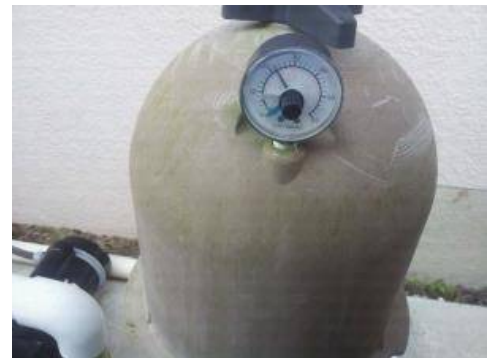
Pressure gauge is operational.

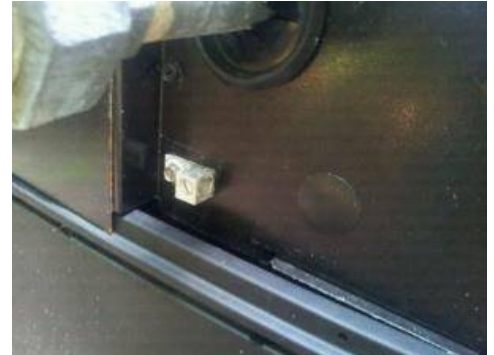
Natural gas. Heating system failed to respond at the time of inspection. It appears no fuel is present. Pilot would not ignite. **Have fuel service checked. Install fuel as needed and re-test operation of gas pool heater.**

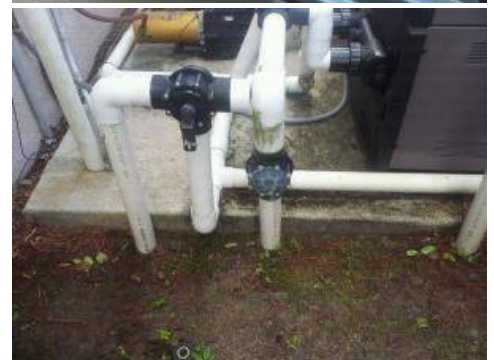
A back flow prevention valve is present and appears operational.

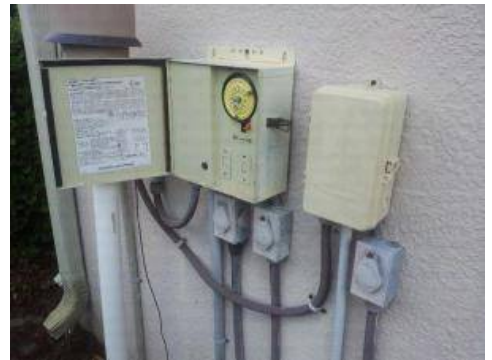
A subpanel is provided- OK, Timer appears to be in operational condition.

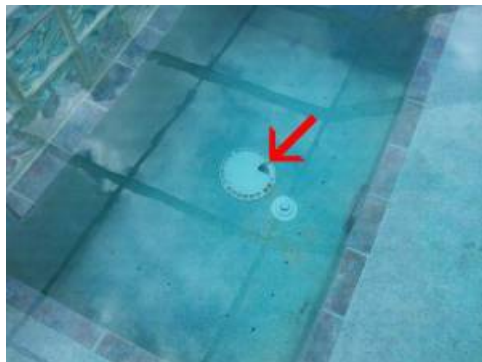
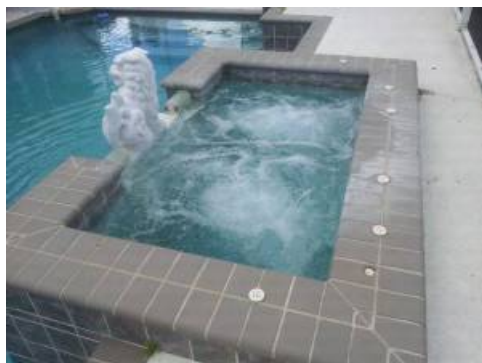
Spa consists of concrete shell and quartz surface and appears in good condition. Pump and motor operate properly and hydrojet action is good at all jets. Air blower is operational, All controls operate properly. The drain cap is damaged. Pieces of the drain cap are located in the leaf trap at the pump filter. **Properly replace the drain cap and remove the broken pieces from the leaf trap near pump.**
